# THE RADIOLOGICAL ACCIDENT IN SAN SALVADOR

A REPORT PREPARED BY IAEA IN CO-OPERATION WITH PAHO/WHO

INTERNATIONAL ATOMIC ENERGY AGENCY, VIENNA, 1990

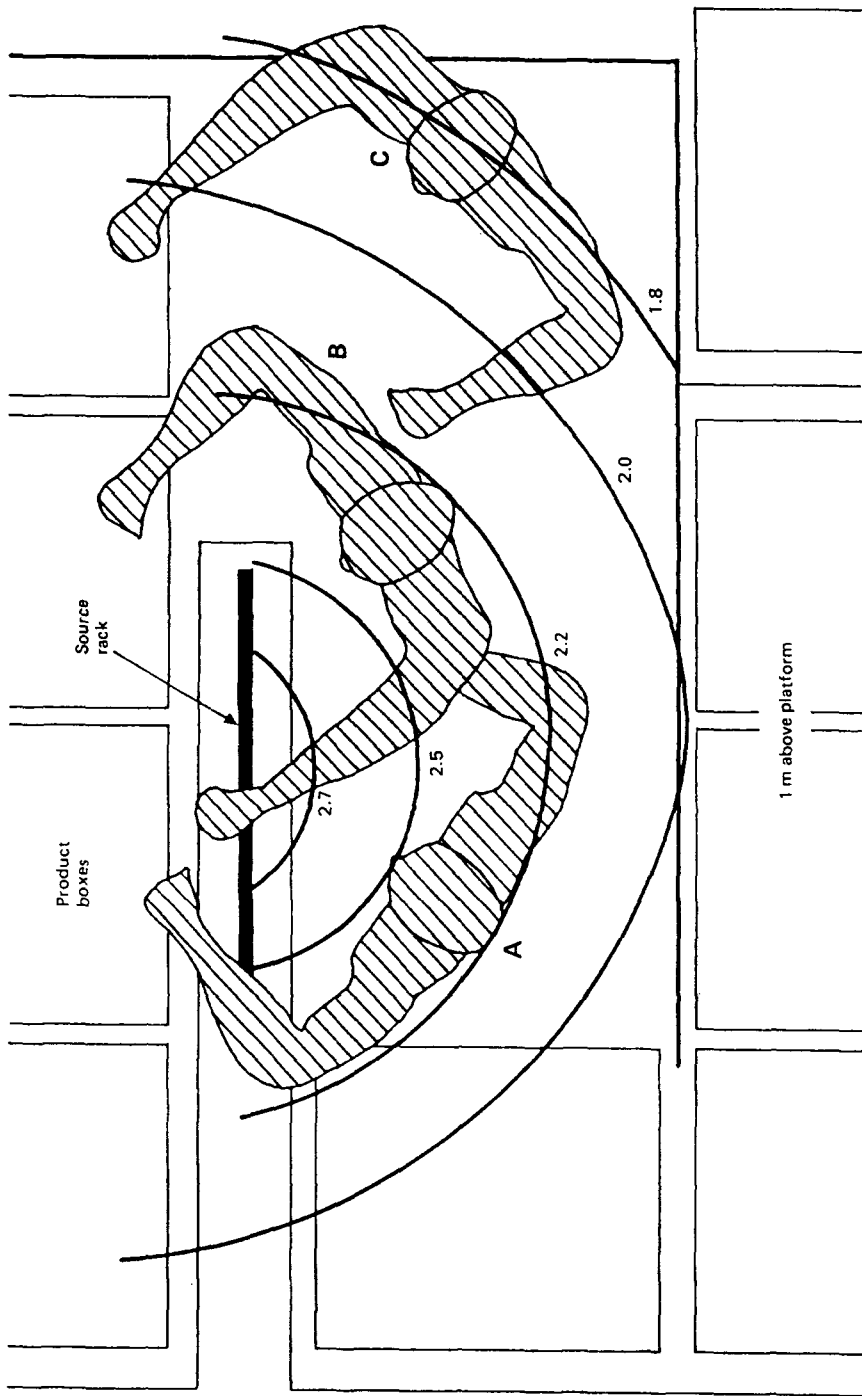
The next phase of the accident was probably when the three workers sustained the largest share of their doses. They would have been moving, but the positions and dose rate contours shown in Figs 13–15 can be taken as indicative of the patterns of exposure. In order to free the source rack they first had to raise it (a mass of about 60 kg) by all three pulling on the hoist cable. Eventually the three men were standing broadly in line on the upper level (Fig. 16). Worker A was in a crouching position with his legs slightly apart and his right leg forward directly in front of the rack. To his right, Worker B had his left leg nearer the source. (The leading leg of each man

FIG. 13. Plan view of the positions in relation to the source rack of Workers A, B and C during the accident with dose rate contours in  $\text{Gy} \cdot \text{min}^{-1}$ . (Source: REAC/TS.)

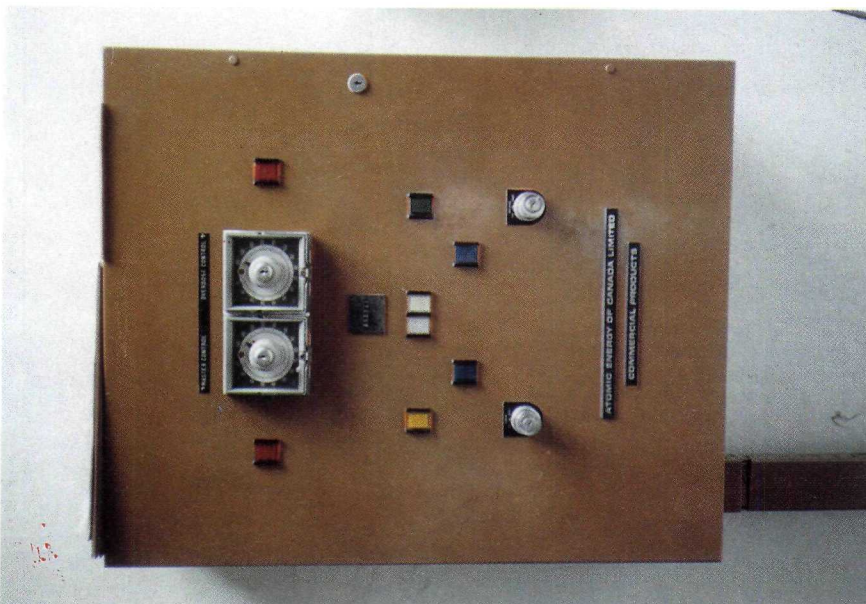
3. The unlabelled control panel.

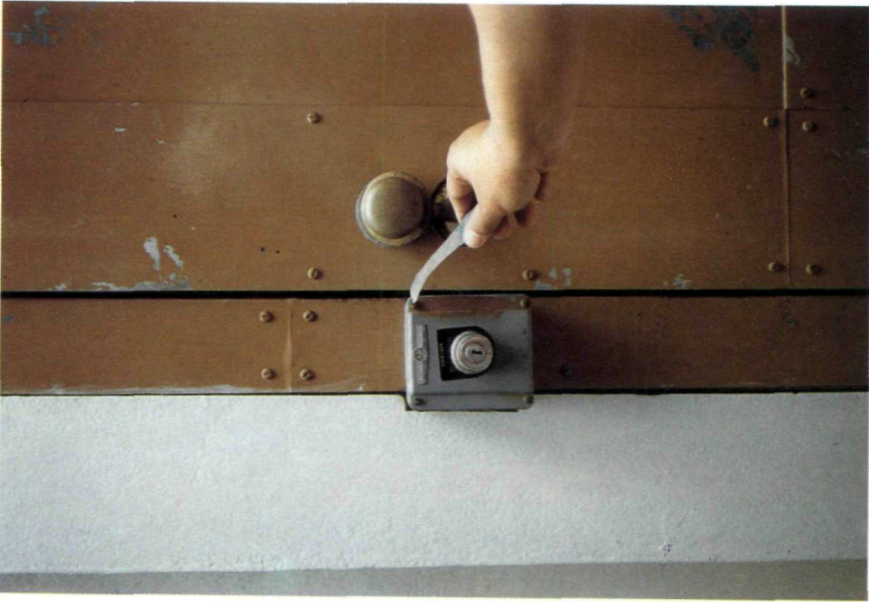
*More than five years before the accident, the monitor probe had failed and the probe assembly had been removed. Its cabling remained. Removal of the monitor probe should have disabled the irradiator. However, it was discovered that access could be gained to the radiation room by depressing the monitor test switch and repeatedly cycling the buttons on the panel of the radiation monitor. This method of gaining access became the 'usual' procedure. The access door had not been maintained and had become badly fitting, with the result that it could also be opened by force or by using the blade of a knife to slip the catch (see Photographs 5 and 6). Thus one major safety feature of the design was bypassed.*

5. *The degraded main door could be opened easily.*

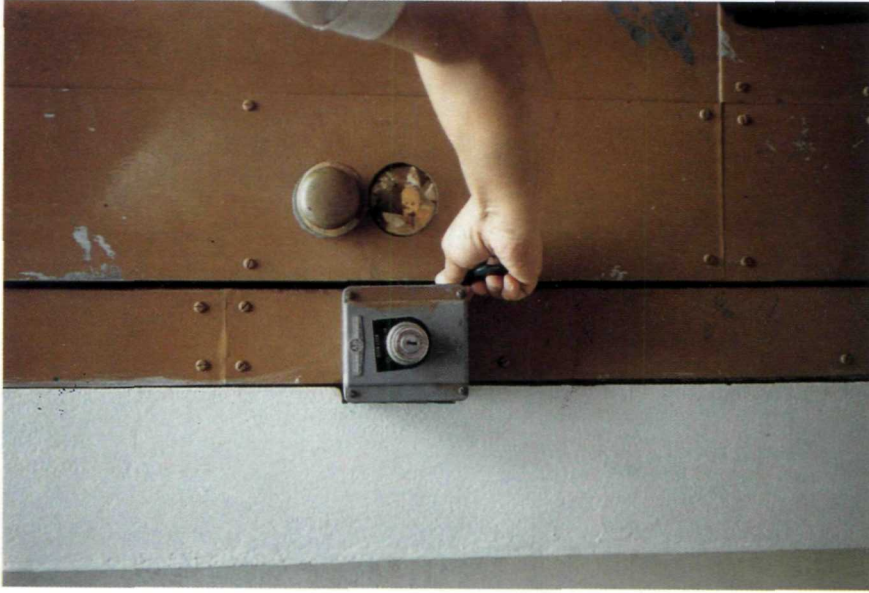
6. *Opening the main door with a knife blade.*

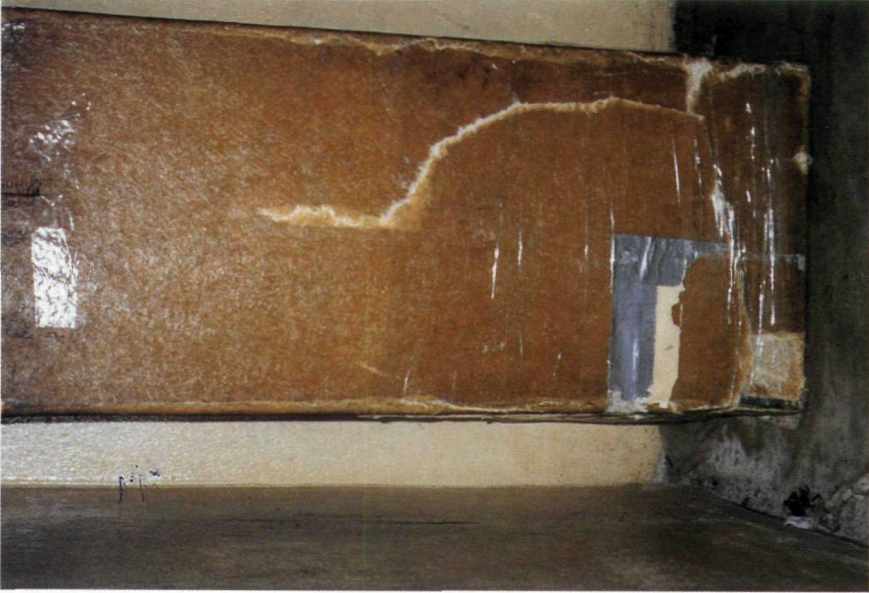
*The owner of the plant received this warning notice but never had its recommendations implemented owing to their cost and the increase in the exposure time that would be necessary to compensate for the shielding effect of the shroud. By the time of the accident in February 1989, the product boxes had been in use for a number of years. Many were in extremely poor condition and had been repaired with adhesive tape.*

9. Fibreglass product box in poor condition.

in which it recommended that a steel source shroud be fitted around the irradiation position. It was also recommended that the condition of the boxes be routinely checked and that boxes in marginal condition be replaced.

*A metal shroud should be installed in such irradiators to protect the source rack from obstruction; product boxes should be inspected regularly and marginal boxes replaced.*

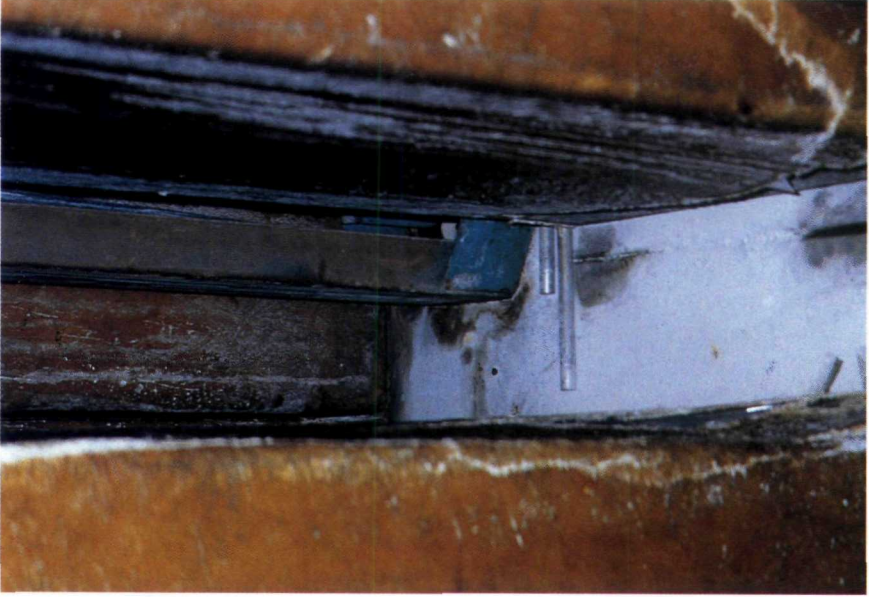
10. Inactive dummy pencils found between product boxes.

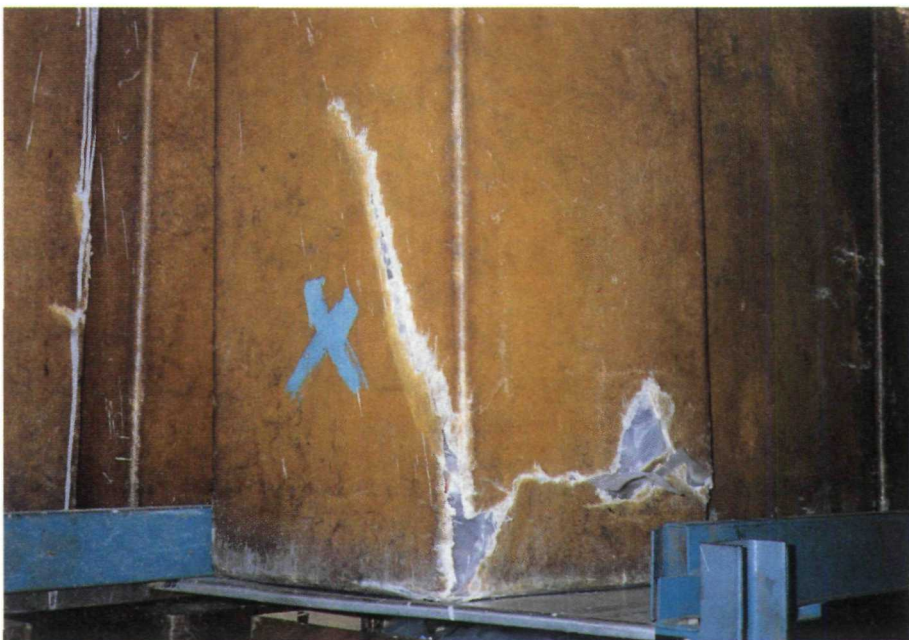
Earlier in the shift, when repairing one of the pistons for this second row, he had found that two boxes had cracks, but since they could still hold the products he had not removed them. These deformed boxes may subsequently have disrupted the system for detecting the positions of the boxes, causing the five boxes to be squeezed into the space for four. The deformation of these boxes probably buckled the metal product guides on the conveyor (see Fig. 6), preventing the source rack from being lowered.

11. A product box could obstruct the source rack.

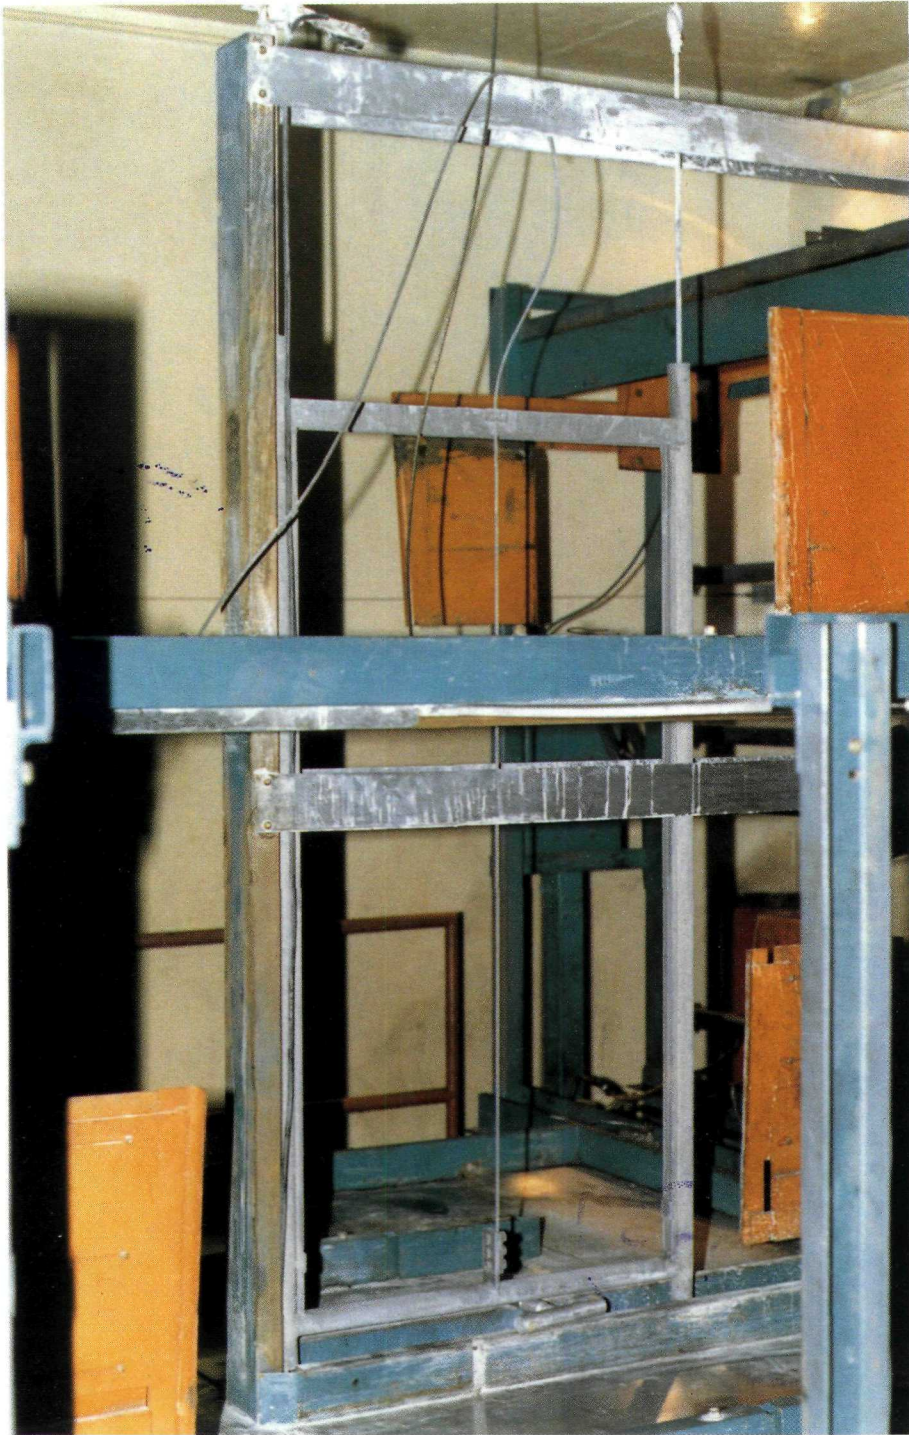
13. *The empty source rack and the entangled source hoist cable.*

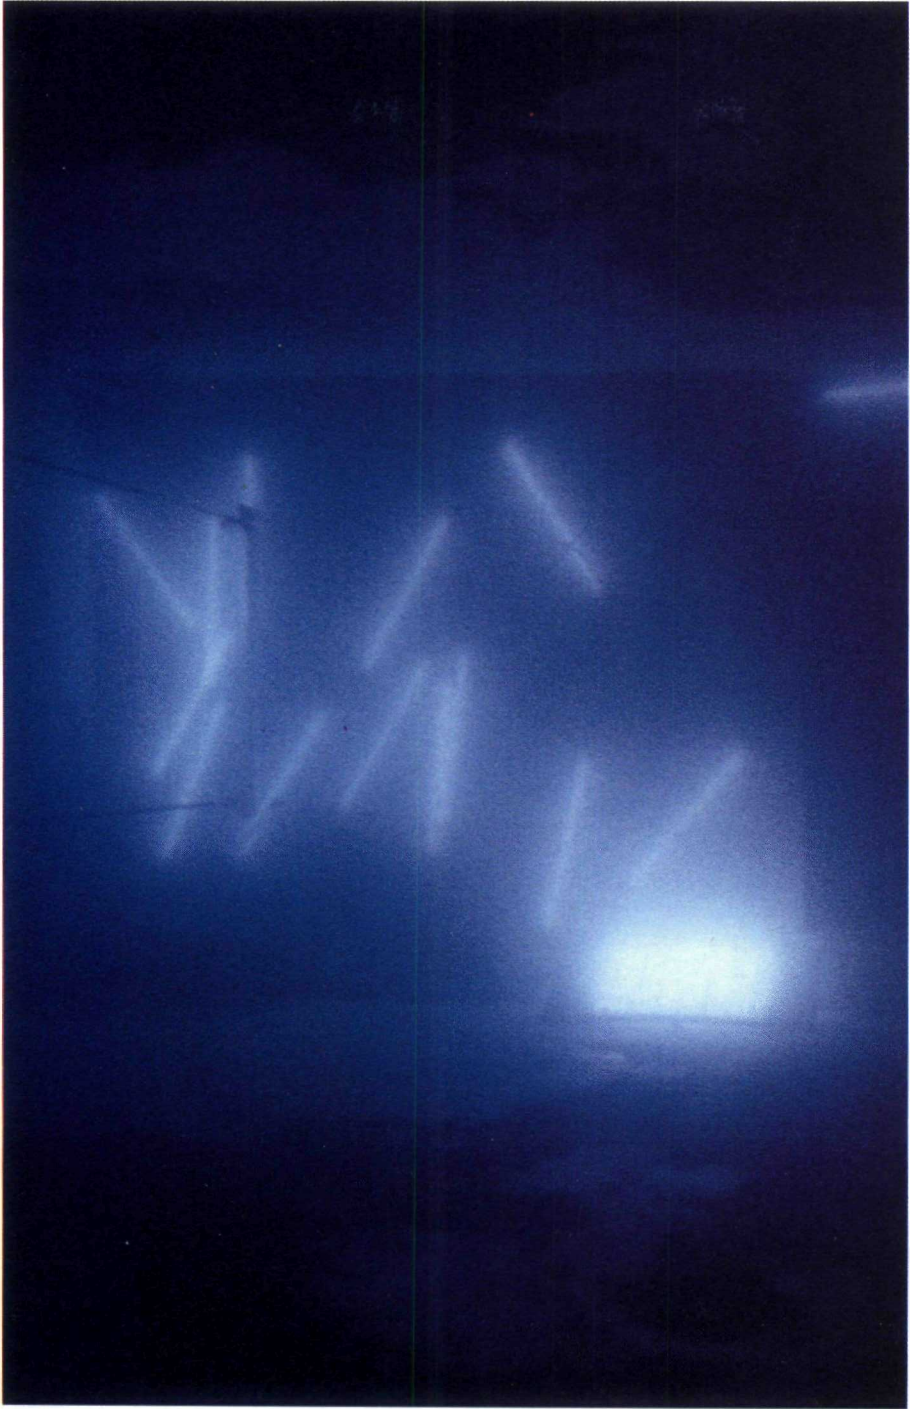
24. The source storage pool showing the Cerenkov radiation which confirms the presence of all fourteen spilled active source pencils.

24. The Cerenkov radiation shows all fourteen source pencils.

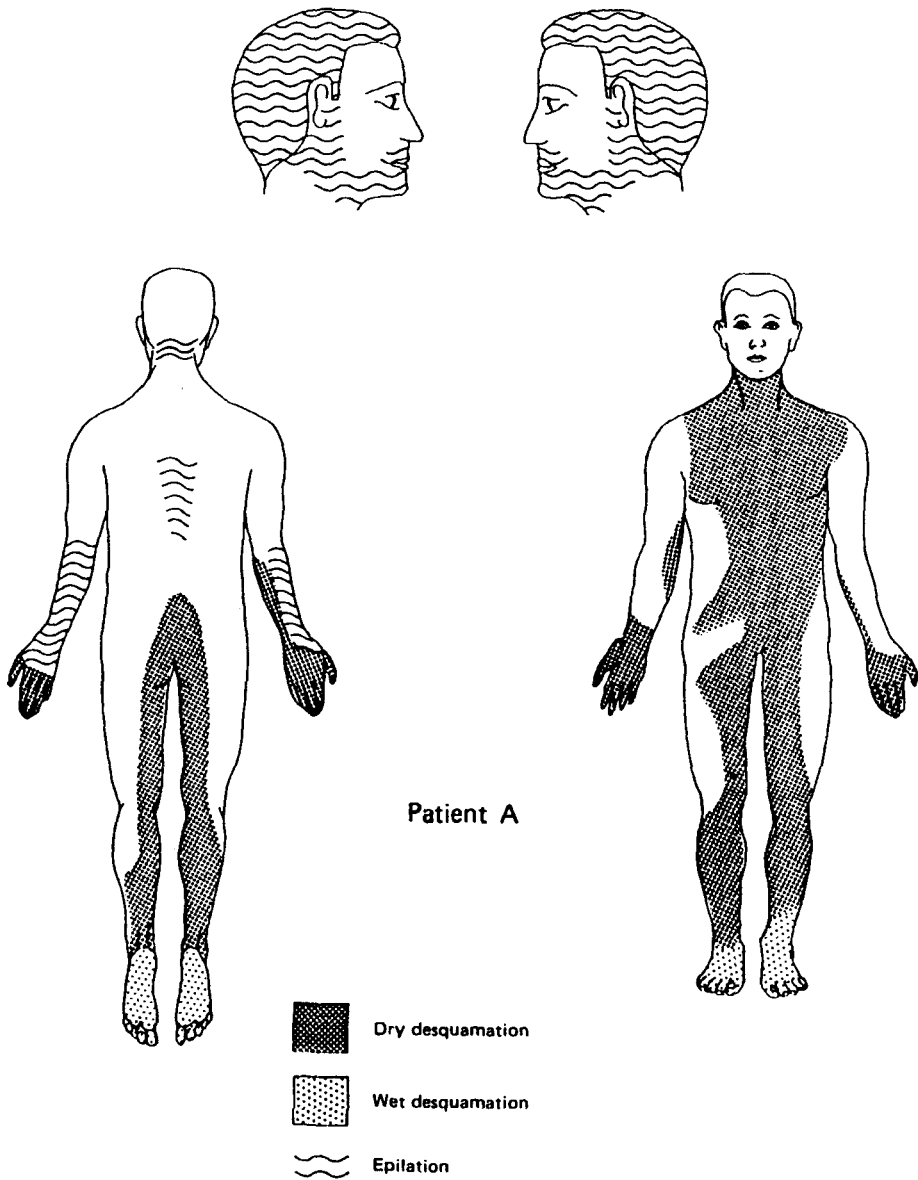
Patient A described his position as shown in Figs 13, 15 and 16. His pattern of desquamation (see Fig. 18) was assessed on the basis that a dose of at least 15 Gy is necessary to cause dry desquamation and a dose of 30 Gy or more for wet desquamation. The results suggest an exposure period of about three minutes. Patient A's

FIG. 18. Patient A: corporal distribution of effects of exposure. (Source: REAC/TS.)
