# A 'Smart' Approach to Building Back Better After Hurricane Irma

## Adina Donovan Home

Road Town, Tortola, British Virgin Islands

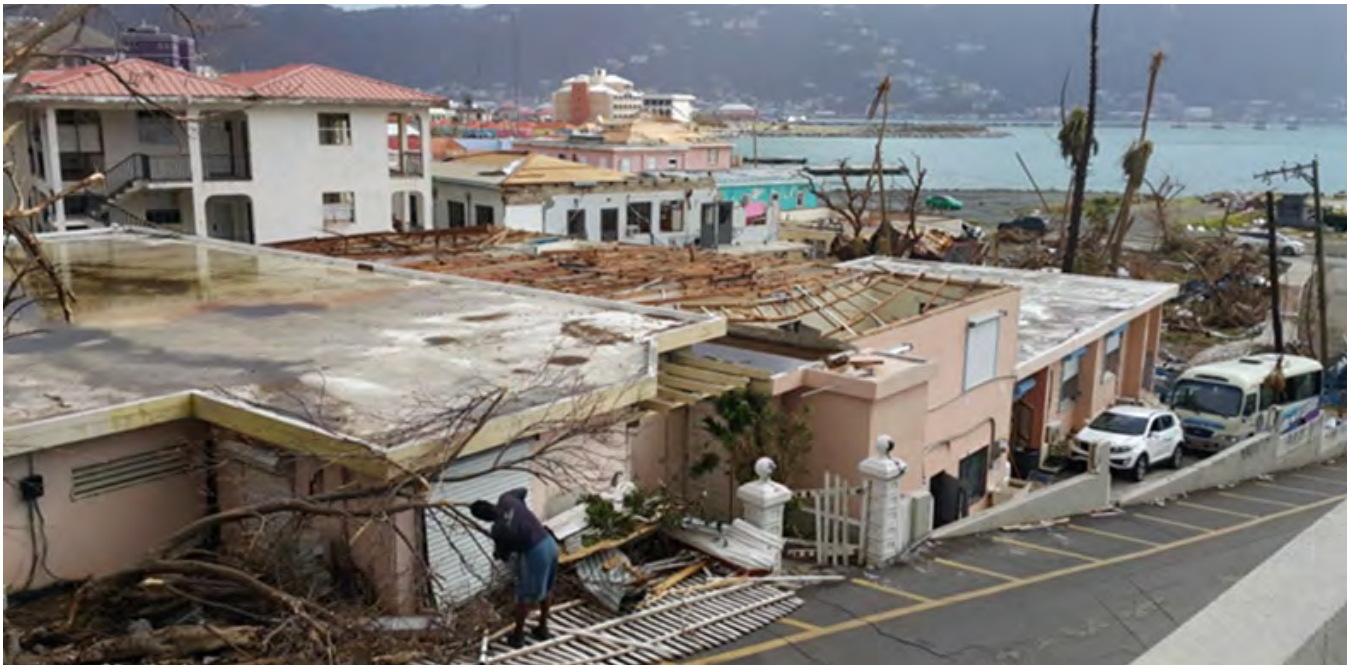
Hurricane Irma impacted the islands on September 6th, 2017 and significantly damaged the facility. The hip roof was removed by the force of the storm and residents in the facility had to be moved to safe areas beneath the concrete roof

sections of the structure. The roof's galvanize sheetings and ceiling boards were uplifted leaving a partial skeletal frame of damaged 2"x4" wooden rafters. No hurricane straps were present in the roof structure. This resulted in water damage, loss of electrical fixtures such as lights and fans; however, no medical equipment was damaged. As a result of the roof being damaged, the stairway and ramp areas were exposed to rainfall which left the ground floor vulnerable to flooding.

Photograph 1: Roof Damage from Hurricane Irma

In an effort to build back smarter at this facility, best practices recommended in the Smart Hospitals Toolkit were employed. The Smart Hospital Toolkit recommends that 'the adaptation response to the expectation of higher wind speeds should be to use structural forms with better aerodynamic properties, for example steeply pitched roofs and regular plan layouts'. The hip roof was strengthened and the slope increased. The existing concrete ring beam was removed and a new one installed. Hip rafters, larger than what existed previously, were used along with,

3" x 8" ridge, 2" x 10" fascia and 3" x 6" rafters spaced at 32" on center. Spiral type galvanized nails were used to fasten all wooden roof elements. The 24-gauge, pre-painted galvalume sheeting was fastened to the underlying 3/4" plywood using double screws at every other corrugation at all eave components. 3/16" x 2" x 12" galvanized plates/straps with 5/8" x 6" galvanized bolts were used to attach 3" x 6" collars at every other rafter. A galvalume ridge cap was utilized and guttering was added to the new roof that will direct captured rainwater to the existing cistern. See roof details below.

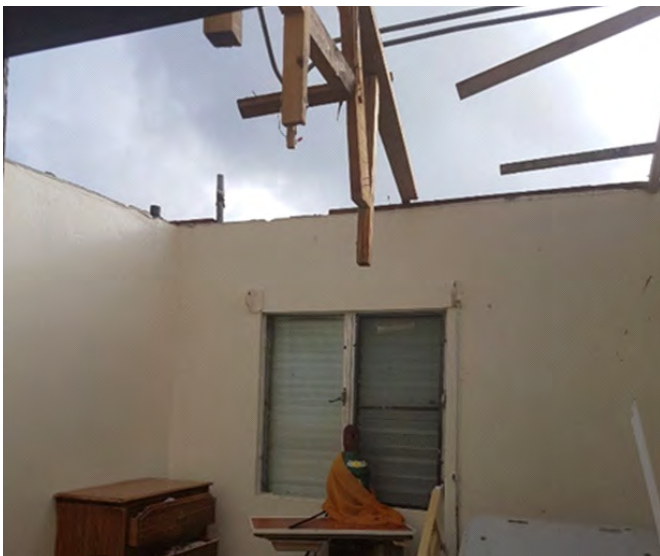
Photograph 2: Damaged Roof Members

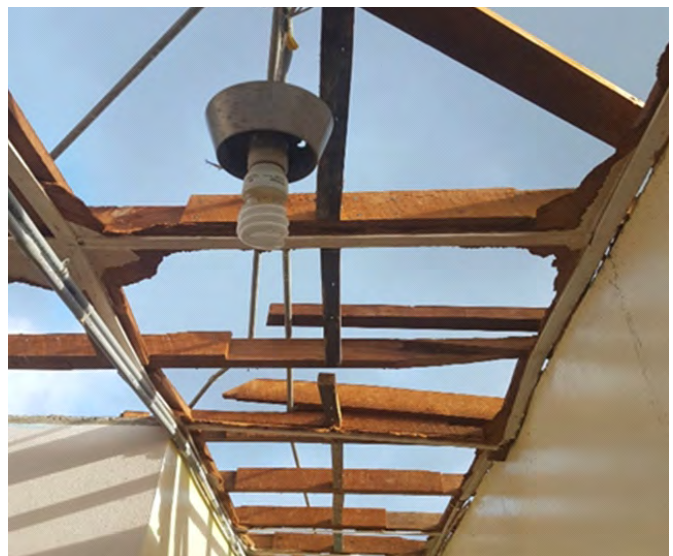
Photograph 3: Removed Sheeting

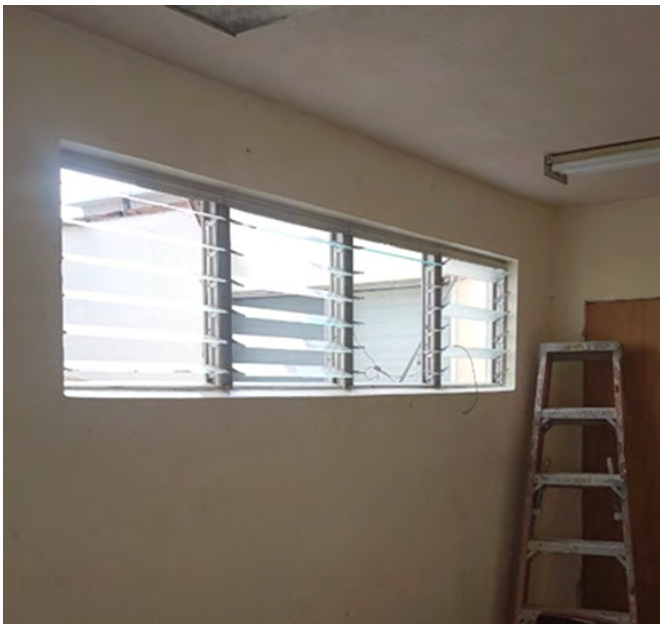
The concrete section of the roof sustained no damage; however, there was water settlement on the slab. Other elements of the facility sustained damage. Some louvered and interior glass louvered windows were damaged, along with one sash window. Hurricane shutters sustained minor damage at the hinges. Two metal doors (including the entrance) with framed glass transom covered by aluminum louvers sustained minor damage; the aluminum louvers were ejected during the storm. A double-swing, wooden

Photograph 4 Damaged Louvered Window

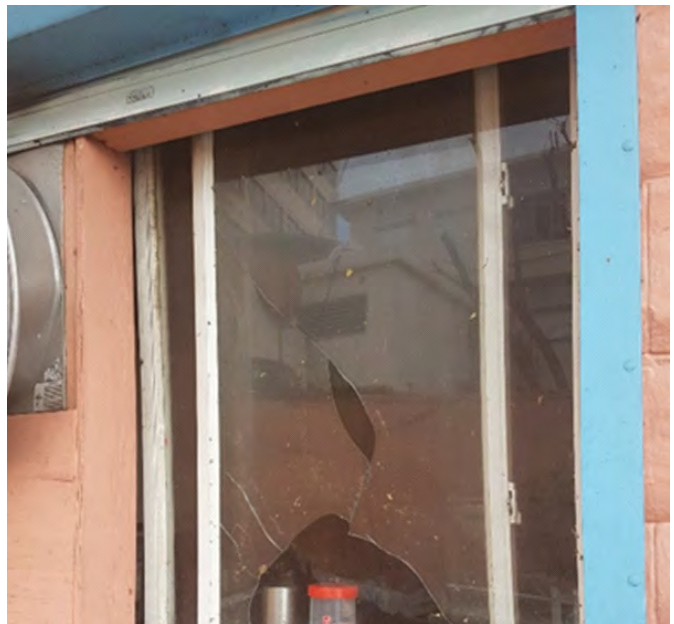
Photograph 5 Damaged Window

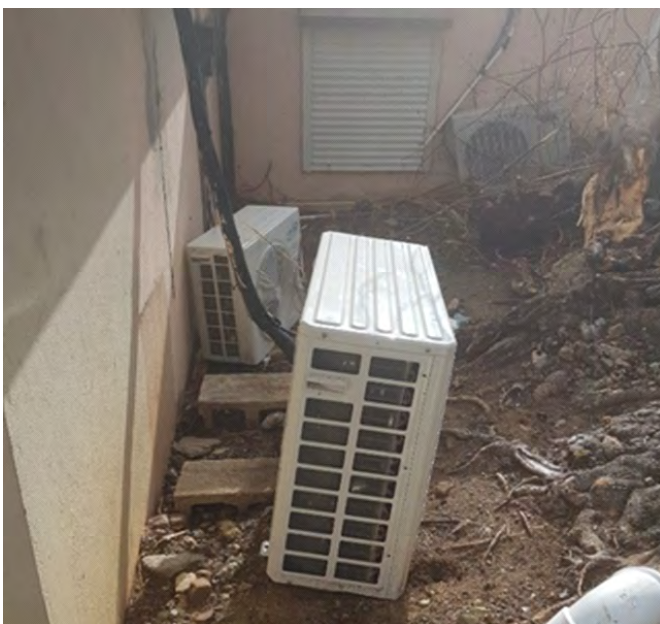
door located on the patio also received minor damage. The double-swing metal laundry door was knocked out by high winds. In terms of the electrical system, exterior lighting fixtures were damaged, junction boxes had missing covers, switches and outlets were damaged by water, air conditioner disconnect switches were damaged and an air conditioner condenser was dislodged. The perimeter fence was also damaged as a result of the high winds.

Photograph 6 Dislodged Condenser

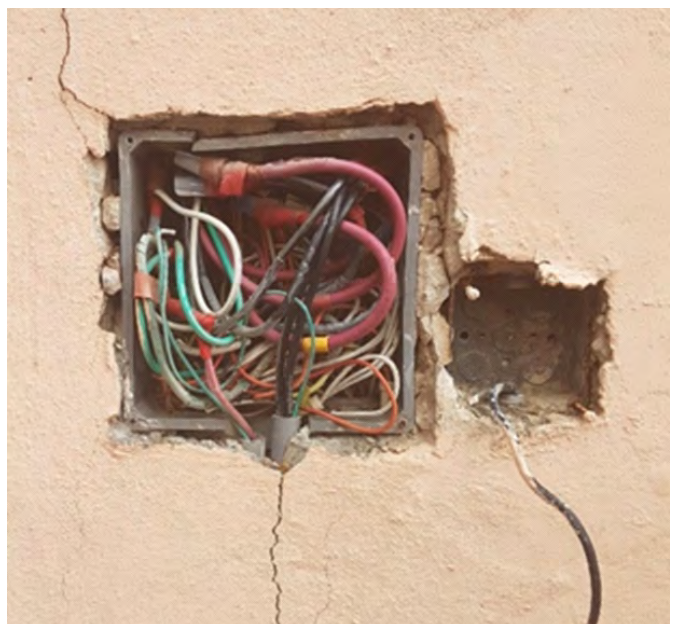
Photograph 7 Missing Electrical Covers

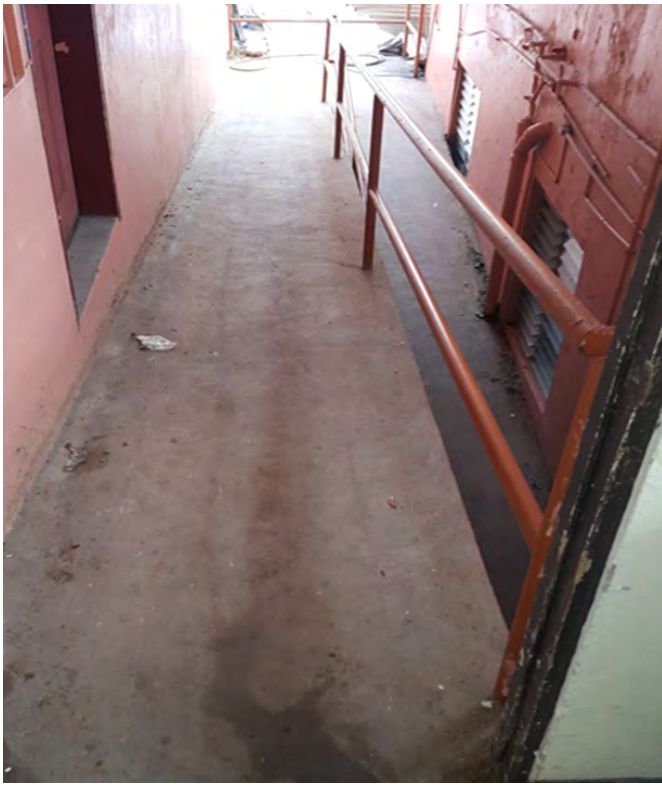
As the renovation was being planned, changes to make the facility safer were also included. For instance, the ramp that joined the front and rear portions of the building was open on one side as depicted in photograph

Photograph 8 Old Open Ramp

below. The open wall was closed up as part of the renovation and a new louvered window added. This allows for safer movement of residents and staff alike while improving lighting to the area.

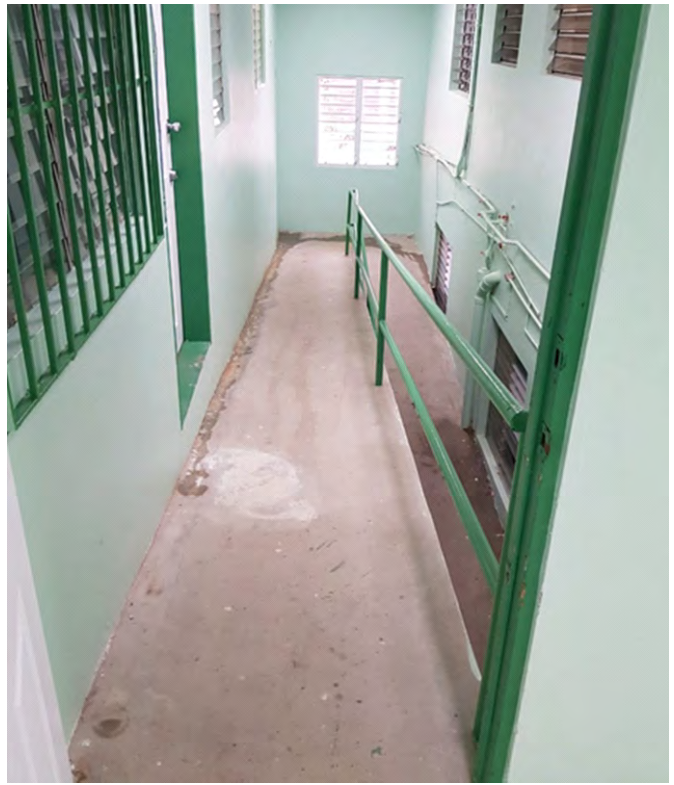
Photograph 9 Enclosed Ramp with New Window

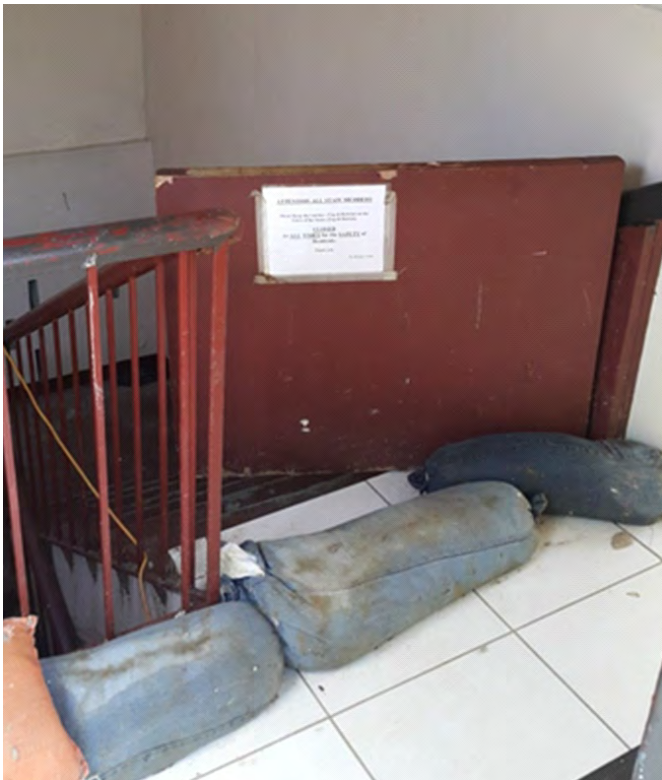
Additionally, a stairway on the interior that previously had a low gate and rail as depicted below, was renovated to include a full sized double-door and glass partition. Safety in this area was greatly improved.

Photograph 10 Old Stairway

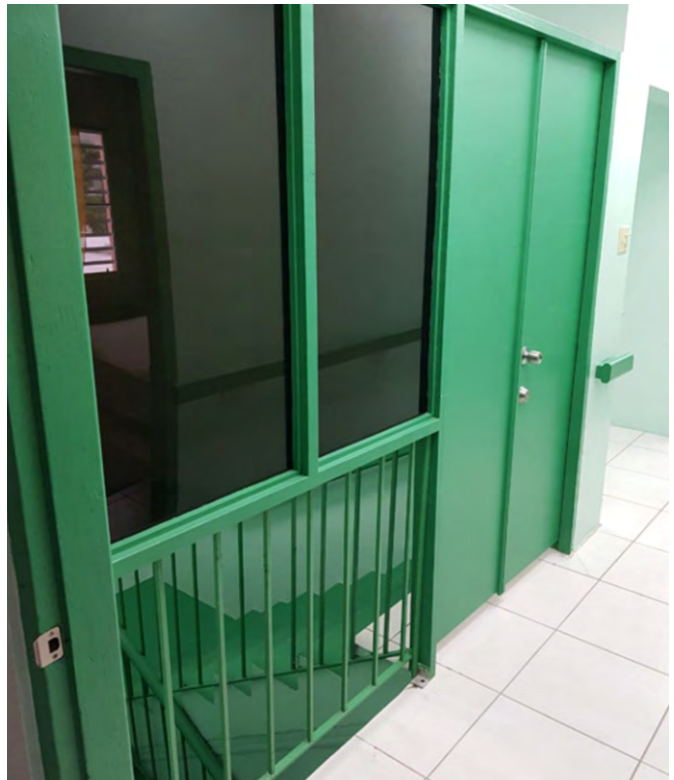
Photograph 11 Improved Stairway

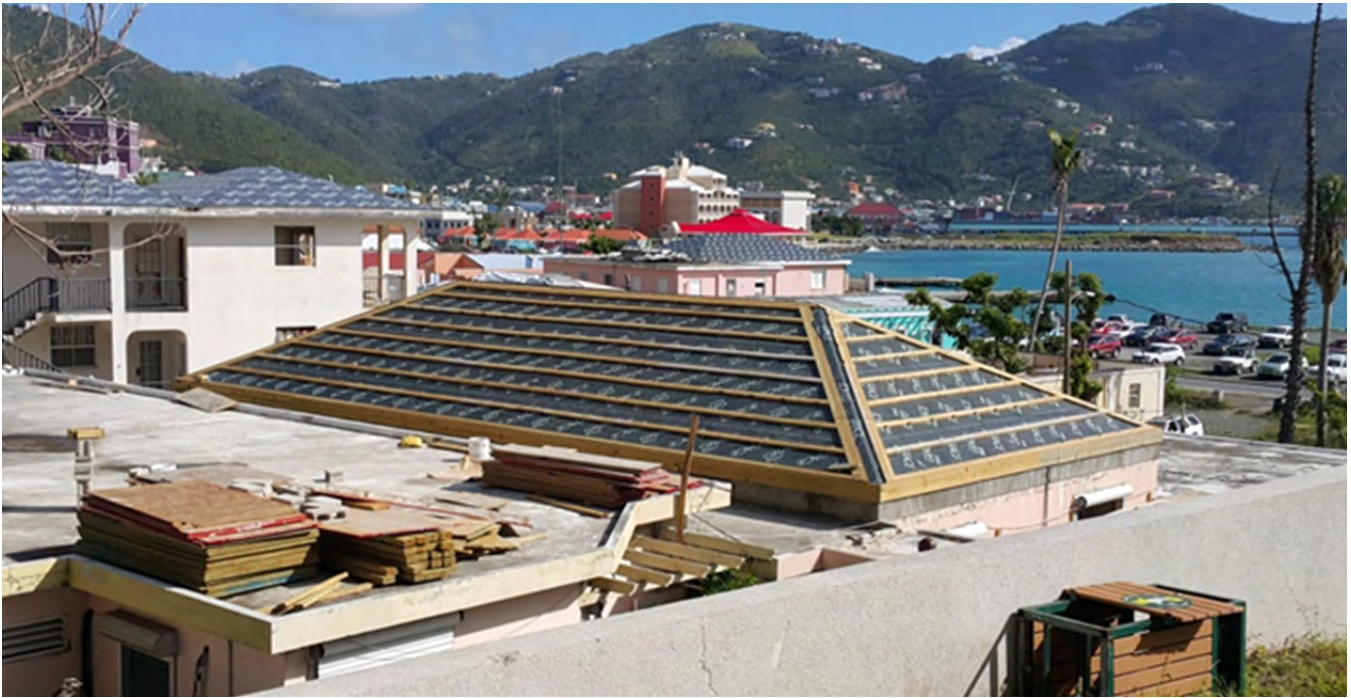
*Photograph 12 Roof Under Renovation*

All the wood used in the new roof was treated to prevent future termite infestation.

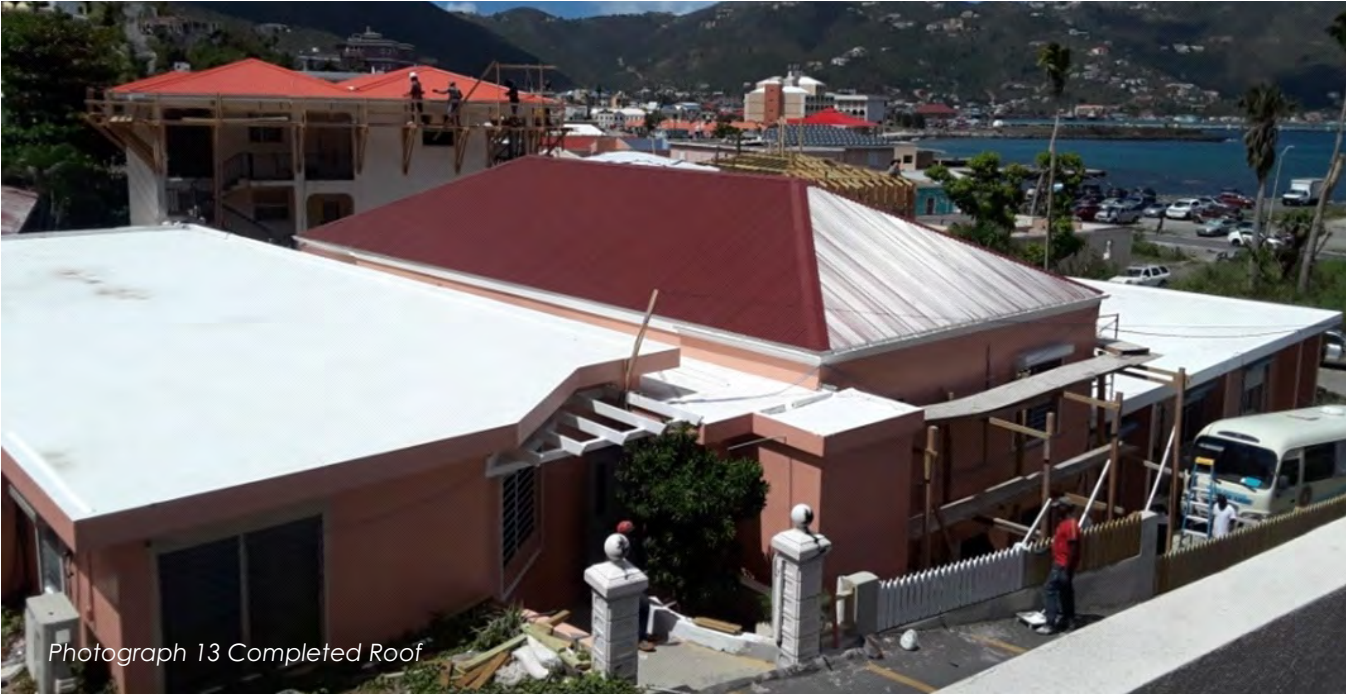
*Photograph 13 Completed Roof*

glare). The waterproof membrane applied to the concrete portions of the roof is colored white as depicted in the picture above. This will help to reflect light/heat and keep the roof cooler and reduce heat transfer into the facility. Insulation sheets were used in the new roof as noted in Figure 3 above.
