An Economic Appraisal of a SMART Hospital

Mark Bynoe and the Economic and Social
Impact Unit
Caribbean Community Climate Change
Centre
8/17/2013

This document presents an economic assessment for retrofitting the Georgetown Healthcare Facility in St. Vincent and the Grenadines. The retrofitted healthcare facility is being carried out under the SMART Hospital Project being funded by the United Kingdom's Department for International Development (UK-DFID). It is expected at the completion of the project the retrofitted health facility will have its structure and resilience enhanced to climate change and extreme weather events, such as categories 4 and 5 hurricanes and tropical depressions. The retrofitted roof has been designed to comply with ASCE 7-05 (as adjusted by the Caribbean Application Document prepared for PAHO by Tony Gibbs) using the wind speed developed as part of the PAHO-USAID study conducted by Peter Vickery of ARA in 2008. The retrofitted roof, therefore, is expected to comply with the strictest security standards against impact, resisting strong winds of up to 150mph and reducing the possibility of forced entry. The retrofitted hospital is also expected to improve th

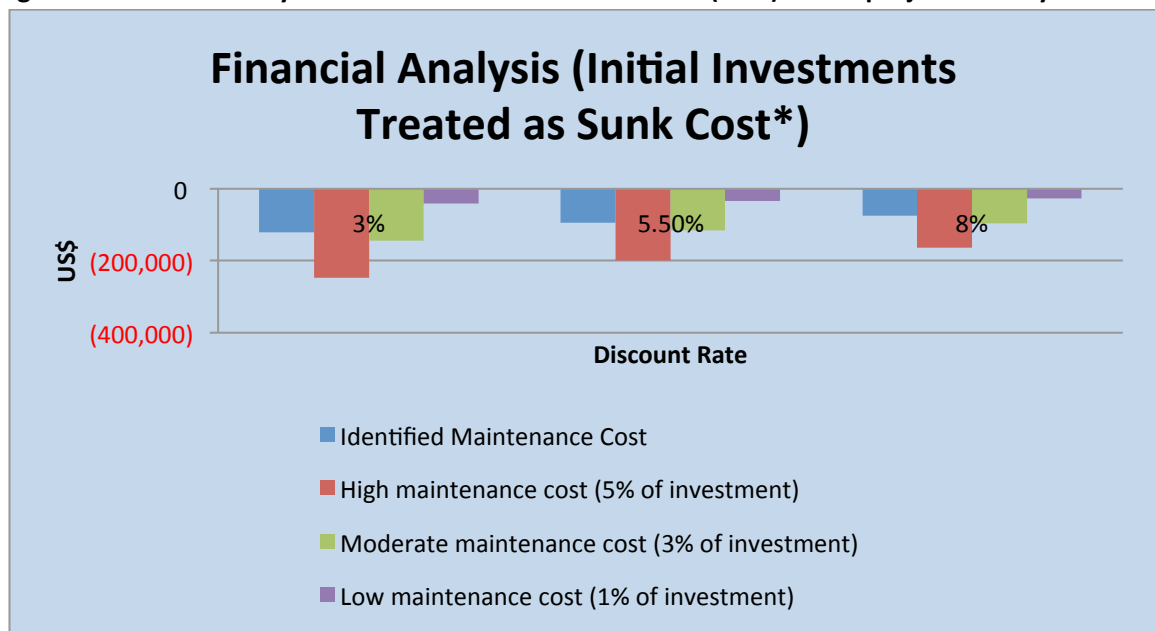
Figure 1: Financial Analysis: Cumulative Net Present Value (NPV) of the project for 20 years

Given the above identified revenue streams, from a financial point of view the project on average could see net losses of US\$1363 to US\$12,360 (2013 prices) per year for 20 years (see Figure 1). The extent of the losses will be dependent on the activities used to operate and maintain the facilities implemented under this project as well as the harnessing of further revenue streams. To financially sustain this project, ways must be found to minimize cost and generate funds. These could include:

*Initial investment is made to be equal to zero as from a financial point of view it cannot be recovery nor does it improve the financial outlook of the project.

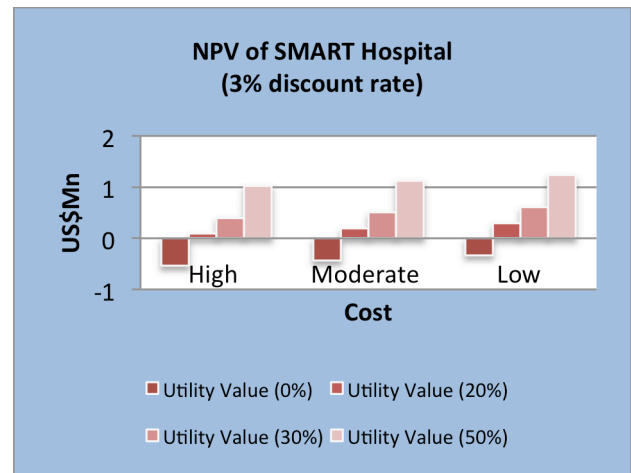
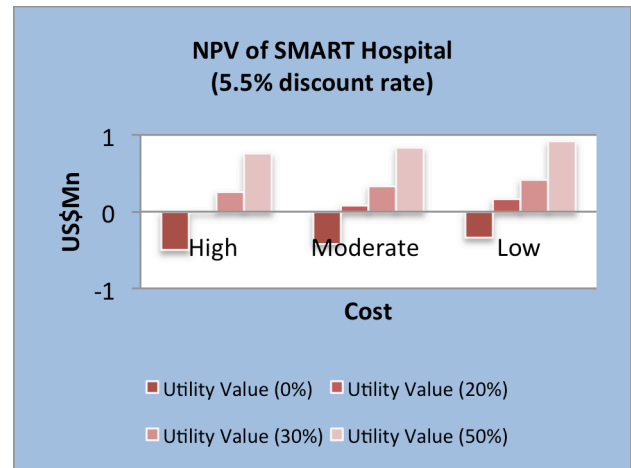
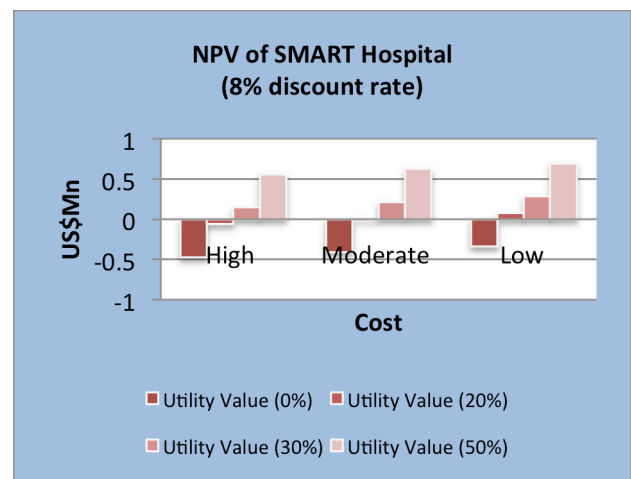
Figure 4: ATP- Economic Analysis (Includes initial investment)

The project is found to have a positive NPV if the value utility per person is about 20% or more of the willingness and ability to pay for health services, which is greater than or equal to US\$11.2 and US\$12 per patient respectively (See Figure 4 and 5).

- In this version of the analysis such utility is valued at 20%, 30% and 50% of the household’s willingness and ability to pay for health services (US\$11.20-12, US\$16.80-18 and US\$28-30 per person respectively). If the value is reduced below 20% of the household willingness and ability to pay for health services, the NPV of the project becomes negative across the three discount rates.
- The operations and maintenance cost also play a big role in determining the

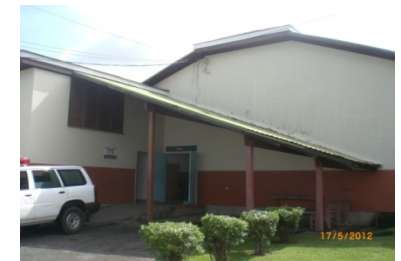
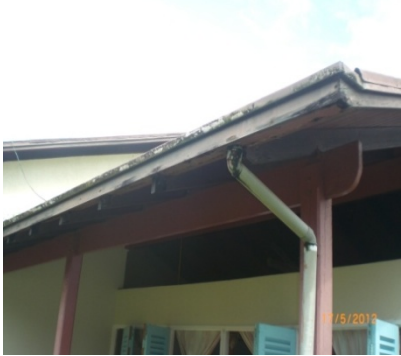
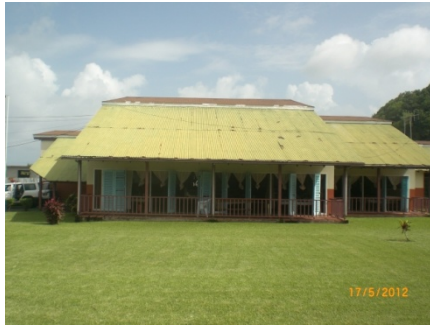
ITEM NO.	AREA/ROOM	ITEM DESCRIPTION (DEFECT, ISSUE)	SCOPE OF WORKS REQUIRED	COST BENEFIT
				PHOTOGRAPHS AS ATTACHED AS GUIDE
2	Roof Renovation Hospital Only	<p>Defect:</p> <ul style="list-style-type: none"> Corrosion and Leaking of the galvanize sheeting. The verandas and the main entry roof are very vulnerable to wind uplift. Water damage to fascia boards. <p>Issue:</p> <ul style="list-style-type: none"> The existing galvanize sheeting on the Hospital shows visible corrosion, wear and tear and water leaks through the joints of the existing tongue and groove ceiling. Roof has no felt/waterproofing layer. Gable roof design is not ideal for high wind/hurricane areas. The roof design has a high potential of wind uplift due to the large extension of the main roof structure over the verandas, at the gable ends and at the main entry roof. 	<p>Works Required:</p> <p>General</p> <ol style="list-style-type: none"> Remove all existing galvanize sheeting material to the main roof including the main entry drop roof section. Remove all hipped end roof sections with asphalt shingle coverings (4 sections total). Replace or make good any damages to the wood rafters and tongue and groove ceiling boards. Install new rafters between existing rafters, new girders to existing girders and construct new capping beam sections with concrete slab in place of the hipped end roof sections, as specified. (See Roof Plan drawings and Appendix for details). Minimize all overhangs to 12 inches, augment all gable ends and install a new guttering system as specified. Separate all main roof overhangs over verandas and install 3 no. new drop shed roof sections (See Roof Plan for details). Extend existing building ring beam and secure all end rafters as specified (See Roof Plan for details). Install felt/waterproofing membrane with treated 2x4 laths and secure to roof (See roof plan for details). Install new heavy gauge galvalume sheeting with corrosive proof fasteners and make good all necessary flashing connections. All galvalume sheeting, fasteners and flashing shall be factory painted with a light color (grey or white) reflective paint. <p>Specifications:</p> <ol style="list-style-type: none"> All roofing material installation shall be conducted in accordance to Manufacturers requirements and in strict compliance with the Local and International building regulations and guidelines. For water guttering system, use commercial grade PVCu Sovereign style guttering system 117 x 55mm (70 cm2); white with all downspouts, parts and fittings. For waterproofing membrane, use 30lb. self- adhesive waterproof felt on roof. For galvalume sheeting, use 24 gauge pre-painted, industrial profile Galvalume sheeting with matching fasteners and flashing. The choice of colour must be approved by Project Manager. 	<p>Benefit:</p> <ul style="list-style-type: none"> To address the roof leaking issues and water damages to the fascia board. To minimize the wind uplift vulnerability on the roof and improve its structural integrity. To ensure effective capture of rain water for use. To improve the roof's bearing capacity to accept the solar panels for the proposed Photo Voltaic (PV) system. The roof retrofit has been designed to comply with ASCE 7-05 (as adjusted by the Caribbean Application Document prepared for PAHO by Tony Gibbs) using the wind speed developed as part of the PAHO-USAID study conducted by Peter Vickery of ARA in 2008. Because of the function and age of the building, the 700-year wind speed has been used.

- e) For any roof painting works, check paints for suitability, and where possible use non-toxic acrylic based paints designed for exterior and roof use. Do not use paints containing lead, chromate, tar/bitumen, fungicides or other toxins as they may pose a health risk and/or may impart an unpleasant taste to the water; colour to be approved by Project Manager.
- f) Do not allow runoff water from the first rainfall to enter the storage tank. Instead it should be discarded or used for nondrinking purposes.
- g) See Appendix for Roof Structural retrofitting specifications.

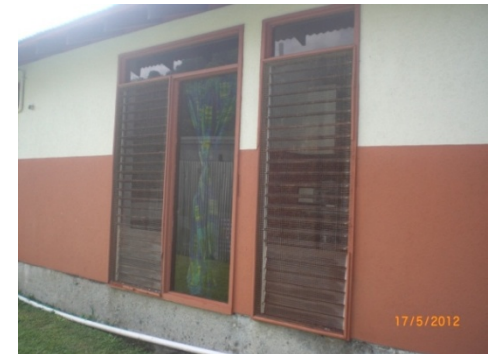
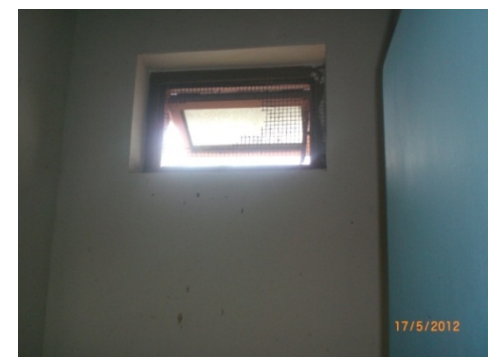
ITEM NO.	AREA/ROOM	ITEM DESCRIPTION (DEFECT, ISSUE)	SCOPE OF WORKS REQUIRED	COST BENEFIT
				PHOTOGRAPHS AS ATTACHED AS GUIDE
3	Windows Hospital only	<p>Defect:</p> <ul style="list-style-type: none"> Inoperable, outdated and not secure. <p>Issue:</p> <ul style="list-style-type: none"> Most of the windows are wooden louvered windows that are water damaged and inoperable. Some of them are even missing louvers and have rusted wire screens as a security barrier. 	<p>Works Required:</p> <p>General</p> <ol style="list-style-type: none"> Remove all windows and transoms from the Hospital. Make good all openings and increase window sill height, as specified. Install Air Master Jalousie windows in all openings with transoms. All windows must be energy efficient, glazed and hurricane rated with security features (see window schedule for size, type and quantity). <p>Specifications:</p> <ol style="list-style-type: none"> All window installation shall be conducted in accordance to Manufacturers requirements and in strict compliance with the Local and International building regulations and guidelines. Air Master Aluminum and Glass Security Jalousie Windows 4" Master Guard 6063 T-5 Aluminum extrusions Polyurethane Powder Coating baked at 400°F after a cleaning and etching process. <ul style="list-style-type: none"> Weather-strip: Virgin vinyl at jambs. Wool pile at vents, head and sill. Glass: 1/4" clear, solex or bronze annealed. Typical Size: 12 blades, 58 3/4" in height x 30" in width each section. 2 sections per installation. Typical size: 3 blades, 16" height x 24" width for restrooms. Typ. Installation for main windows: Window sill height shall be raised 2'-0" above finish floor level (FFL) or as specified. Air Master Aluminum and Glass Continental Picture Windows Series Fourth Generation. 6063-T-5- Aluminum Extrusions 0.062" gauge. <ul style="list-style-type: none"> Finish - Polyurethane powder coating baked at 400 degrees F after a cleaning and etching process. Weather-stripping – virgin vinyl at perimeters of vent and at head, sill and frame jambs. Glass – 1/4" annealed glass or 5/16" Hurricane Resistant Glazed consisting of (2) 1/8" annealed glass and (1) 0.090" P.V. B interlayer. Perimeter frame corners cut at 45 degrees. Typical Size: 13" height x 60" in width for transoms or match to fit typical two (2) section window installation. 	<p>Benefit:</p> <ul style="list-style-type: none"> To improve the Hospital ventilation and provide an increase level of security. To increase the Hospitals resilience to hurricane disasters. Air Masters complies with the strictest security standard against impact, resisting strong winds of up-to 150mph and reducing the possibility of forced entry.

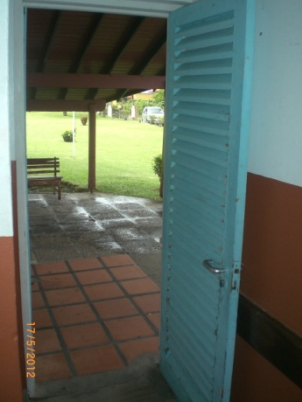
ITEM NO.	AREA/ROOM	ITEM DESCRIPTION (DEFECT, ISSUE)	SCOPE OF WORKS REQUIRED	COST BENEFIT
				PHOTOGRAPHS AS ATTACHED AS GUIDE
4	Doors: Interior and Exterior Hospital only	<p>Defect:</p> <ul style="list-style-type: none"> Exterior doors are damaged and lack sufficient security features Interior doors are damaged and lack hygienic features <p>Issue:</p> <ul style="list-style-type: none"> Most of the exterior doors are plantation style/wooden doors with fixed louvers that are ineffective against wind driven rain and debris and offer no level of security. Most of the interior doors and jambs, especially in the restroom areas, are water damaged and lack proper door knobs. 	<p>Works Required:</p> <p>General</p> <ol style="list-style-type: none"> Remove all interior and exterior doors and make good all openings. Install new exterior doors with fire rated exit doors with panic mechanism and glass sash (see door schedule for exterior door type and quantity). Install new interior doors with GRP hygienic fire rated doors equipped with anti-microbial door handles and fixtures (see door schedule for interior door type and quantity). Remove all bi-fold wooden louvered doors at the male, female and maternity wards with hurricane rated doors (See door schedule for door type and quantity). <p>Specifications:</p> <ol style="list-style-type: none"> All door installation shall be conducted in accordance to Manufacturers requirements and in strict compliance with the Local building regulations and guidelines. For all door specifications, see door schedule for information. 	<p>Benefit:</p> <ul style="list-style-type: none"> To improve the Hospitals protection from the elements accessibility and security. To improve the level of hygiene throughout the Hospitals. <p>Exterior Doors Of Hospital</p>

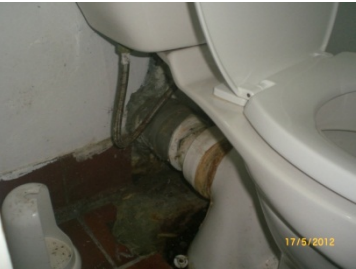
</div> </div> <div style="text-align: center;"> <p>Condition of Back-flush Toilets in all restrooms</p>

ITEM NO.	AREA/ROOM	ITEM DESCRIPTION (DEFECT, ISSUE)	SCOPE OF WORKS REQUIRED	COST BENEFIT
				PHOTOGRAPHS AS ATTACHED AS GUIDE
5	Plumbing Works & Sanitary Fixtures Hospital only	Defect: <ul style="list-style-type: none"> • Most fixtures are leaky and outdated. • All sink traps are in bad shape and restrooms have no floor drains. • Most back-flush toilets are outdated and damaged. • Shower stalls are unusable and unfinished. Issue: <ul style="list-style-type: none"> • Most of the faucets and shower heads in the restrooms are constantly leaking. They have no proper shut off valves. All of the face basins have derelict sink traps. • The shower stalls are in disrepair and require repair. • Most of the toilets are outdated, back flush toilets and most of them are not flushing properly. • There are no urinals in the male restrooms. • There are no floor drains in the restrooms which most times flood due to the leaking faucets. 	Works Required: General <ol style="list-style-type: none"> All plumbing installations shall be conducted in accordance to the Manufacturers requirements and in strict compliance with the Local building regulations and guidelines. Restrooms <ol style="list-style-type: none"> Replace all face basins and faucets with wall mounted sinks in the restrooms as specified. Replace associated plumbing with aerated sink traps, fittings and shut-off valves as specified. Refurbish all cold water supply lines as specified with shut off valves. Reorganize bathroom plumbing to utilize both rainwater and potable water. Install floor drains to minimize flooding of the restrooms (see restroom drawings for locations and details). Replace all the existing toilets with commercial grade toilets and install urinal in male restroom as specified (see restroom drawings for details). Install new shower stalls (4 No.) as per drawing and make allowance for hot water supply and new water efficient fixtures as specified. Kitchen <ol style="list-style-type: none"> Remove all sink traps and replace with aerated sink traps, fittings, cleanouts and shut-off valves. Refurbish all sinks (2 No.) and make good all sink connections. Refurbish all cold and hot water supply lines as specified with shut off valves. Reorganize plumbing to utilize both rainwater and potable water. Install grease trap interceptor and connect to both kitchen sink outlets as specified. Sluice Room <ol style="list-style-type: none"> Remove all wall mounted faucets, water storage tanks, sluice sinks (1 No.) and traps with aerated sink traps, fittings and shut-off valves as specified. Install new sluice unit and make good all sink connections including 	Benefit: <ul style="list-style-type: none"> • The installation of new faucets, face basins, shower heads and PVC shut-off valves and pipe refurbishment will eliminate pipe leaks and water wastage. • The toilet upgrades will reduce blockages and promote water savings. • The re-organization of the plumbing will retain the facilities flexibility to have access to both potable and rain water in the event of water shortages. • It will improve the level of hygiene and venting of the pipes throughout the Hospital. <div style="display: flex; justify-content: space-around;"> <div style="text-align: center;"> <p>Male Restroom</p>

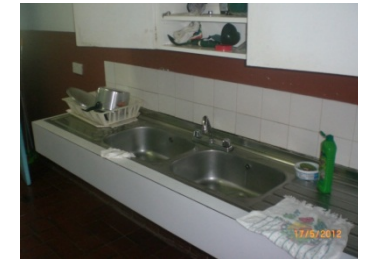
Condition of Kitchen Sinks & Traps

- a) Remove all sink traps and replace with aerated sink traps, fittings, cleanouts and shut-off valves.
- b) Refurbish sinks (1 No. per room) and make good all sink connections.
- c) Refurbish all cold and hot water supply lines as specified with new shut off valves.
- d) Reorganize plumbing to utilize both rainwater and potable water.

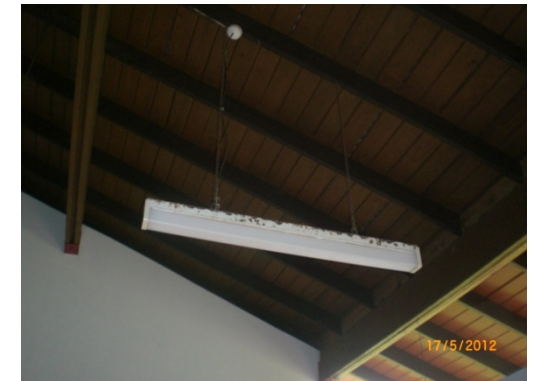
ITEM NO.	AREA/ROOM	ITEM DESCRIPTION (DEFECT, ISSUE)	SCOPE OF WORKS REQUIRED	COST BENEFIT
				PHOTOGRAPHS AS ATTACHED AS GUIDE
6	<p>Electrical Works- Lights & Power</p> <p>(Lights- Interior and Exterior, Light switches, Receptacles, Breaker Panels, Emergency lights, Emergency Exit signs and Exhaust fans)</p> <p>Hospital only</p>	<p>Defect:</p> <ul style="list-style-type: none"> • Outdated breakers and breaker panels. • Non-operational/Insufficient lights, switches and electrical receptacles. • Exposed electrical wiring <p>Issue:</p> <ul style="list-style-type: none"> • Most of the electrical light fixtures are not working, outdated and rusted. • Some of the lights are insufficient and doesn't provide adequate light especially in areas where the ceiling is very high. • Some of the receptacles are inoperable and require GFCI rating based on their locations. • Some of the light switches are inoperable in some areas and others are located in inappropriate locations in relation to their corresponding light unit. • The perimeter lights are not adequate and needs to be placed in effective areas around the building. • The building electrical systems are outdated and require an overall upgrade including all wiring, grounds and electrical breakers. 	<p>Works Required:</p> <p>General</p> <ol style="list-style-type: none"> Conduct an overall electrical re-wiring of the building and make allowance for all works involved with cutting holes, chases, conduits and electrical services installations through and in roofs, floors and walls. Upgrade all electrical receptacles, lights, switches, breaker panels and wiring in areas as specified on the detailed electrical drawings. To include all fixtures, fittings, energy efficient bulbs and other specified accessories. Make provisions for Surge protection and a transformer unit if necessary. <p>Specifications:</p> <ol style="list-style-type: none"> All Electrical installations shall be in accordance to the Manufacturers specifications and in strict compliance with local and international building regulations and guidelines. All light bulbs and fixtures shall be used to accommodate T8 LED fluorescent tubular bulbs. (See electrical light drawings for fixture type, location and quantities). See electrical light drawings for other light bulb and fixture type specified. 	<p>Benefit:</p> <ul style="list-style-type: none"> • It will improve the poor lighting conditions and reduce energy demand. • It will improve the safety of the building and enhance the buildings level of security.

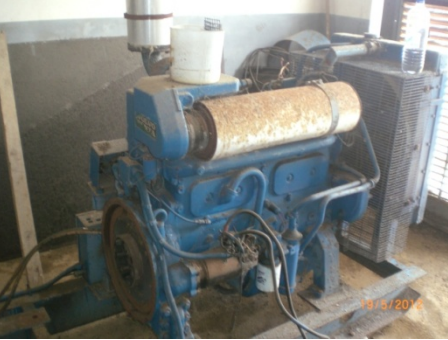
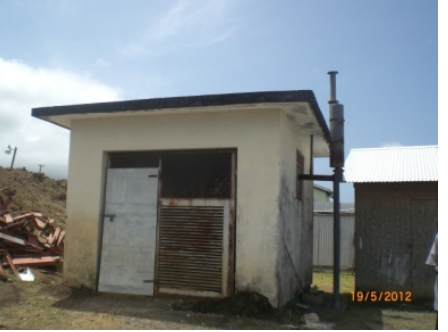
ITEM NO.	AREA/ROOM	ITEM DESCRIPTION (DEFECT, ISSUE)	SCOPE OF WORKS REQUIRED	COST BENEFIT
				PHOTOGRAPHS AS ATTACHED AS GUIDE
7	<p>Electrical Works – Emergency Power Supply</p> <p>Hospital and Clinic</p>	<p>Defect:</p> <ul style="list-style-type: none"> Non-operational and outdated <p>Issue:</p> <ul style="list-style-type: none"> There is no operational backup power supply that supports both the Hospital and the Clinic. 	<p>Works Required:</p> <p>General</p> <ol style="list-style-type: none"> Disconnect all electrical connections from the existing generator and make allowance for all necessary trenching, concrete surrounds, sand bed earthing support and all electrical service installations. Install and size new emergency backup generator capable of supplying both the Hospital and Clinic (To be sized based on the facilities energy consumption of 16.58 Kw). Retrofit/renovate the emergency generator housing to allow for better security and ventilation. To include replacing the exterior access doors, all interior lights, switches and receptacles. Also install exterior security lighting at entrance and rear of housing. <p>Note: Provisions should be made for only the Hospital/Clinic. The new Dialysis building should acquire its own emergency power supply.</p> <p>Specifications:</p> <ol style="list-style-type: none"> All Electrical installations shall be in accordance to the Manufacturers specifications and in strict compliance with local and international building regulations and guidelines. Automatic transfers switch (ATS) to be sized and compatible with new emergency generator. The exterior door shall be a fire rated metal door with fixed louvers to allow for ventilation and with heavy duty corrosion resistant handles, knobs and hinges. Size shall be 6’ wide x 7’-0” high. The interior lighting shall be 2 no energy efficient light bulbs with heat resistant industrial fixture covers. The exterior lighting shall entail motion sensor, double flood bulb security light fixtures with energy efficient bulbs at the main entrance and rear of the housing. To be mounted under corners of the roof overhang. Make allowance for a 4 ft. deep x 6” thick x length of the housing (at entrance) reinforced concrete slab on grade to prevent water and mud from entering the building. 	<p>Benefit:</p> <ul style="list-style-type: none"> To provide a reliable, back-up supply of electricity to both the Hospital/Clinic when the public supply and the PV system are down. To improve the level of ventilation and security features of the generator housing this will provide optimum operation of the generator and increase its life cycle. <p>Condition of the Emergency Generator & Housing</p>

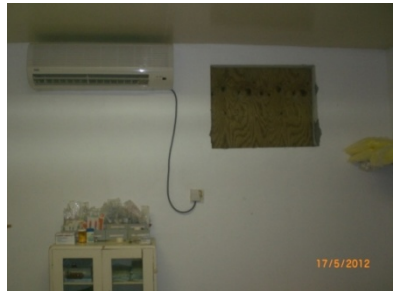
ITEM NO.	AREA/ROOM	ITEM DESCRIPTION (DEFECT, ISSUE)	SCOPE OF WORKS REQUIRED	COST BENEFIT
				PHOTOGRAPHS AS ATTACHED AS GUIDE
9	<p>Mechanical Works – Ventilation, Hot water systems, Cooling systems and Water catchment</p> <p>Hospital</p>	<p>Defect:</p> <ul style="list-style-type: none"> • Non-operational • Inadequate water storage capacity. • Lack of water treatment <p>Issue:</p> <ul style="list-style-type: none"> • There is no hot water supply in the hospital. • There is only one air condition unit in the hospital delivery room which is not working and the room has no other means of ventilation. • The kitchen gets very hot during day especially when cooking. No proper ventilation to remove the heated air. • There is no capture of rain water. The existing 1,000 gallon capacity water tanks (rest on top of an abandoned cistern) are insufficient and are dependent on the potable water supply to refill them and provide water for both the Hospital and Clinic. 	<p>Works Required:</p> <p>General</p> <ol style="list-style-type: none"> Install electric water heaters and make allowance for pipe works, plumbing and electrical service installations through and in roofs, floors and walls. Install energy efficient split air condition units in rooms and areas as specified in the electrical light drawings. Make provisions for cutting holes, pipe works, ducts, plumbing and all electrical installations Install ceiling exhaust fans in the restrooms, sluice, and delivery rooms as specified in the electrical light drawings. Install an range hood extractor fan system over the existing stove in the kitchen, as specified. Make provisions for cutting holes, ducts and any electrical installations. Installation of commercial grade, energy efficient ceiling fans in designated areas as specified. Make provisions to allow for electrical installations through the roof and for railing system for high ceiling mounted fans. Install new water storage tanks with mounting hardware as specified. Make provisions for all plumbing works, the installation of a water filtration system and the extension of the existing cistern platform for increased water storage capacity. Install and size new water pump for both Hospital and Clinic (See water usage data in Appendix). <p>Note: To determine the project cost benefit analysis, the water meter must remain only for the Hospital and Clinic. The New Dialysis building must acquire its own water meter.</p> <p>Specifications:</p> <ol style="list-style-type: none"> All mechanical installations shall in accordance to the Manufacturers specifications and in strict compliance with local and international building regulations and guidelines. Air condition units shall be ductless, split units with SEER (Seasonal Energy Efficiency Ratio) of 13 or higher and appropriately sized (BTU) for designated rooms. The Electric water heaters shall be energy star rated with a capacity to cater for all showers and sinks. All exhaust fans shall be energy rated and specified as per electrical 	<p>Benefit:</p> <ul style="list-style-type: none"> • Hot water supply will help in the sterilization/cleaning of utensils, bed pans and other items within the facility. • Improved ventilation and the installation of cooling systems will improve patient/staff use satisfaction and also improve indoor air quality. • Allow for the use, collection and increased water storage capacity of rain water throughout the facilities and minimize the reliance of potable water supply. <p>Air condition unit in the Hospital delivery room with its only window blocked</p>

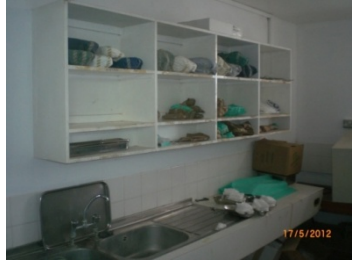
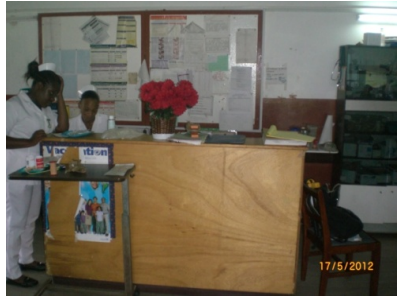
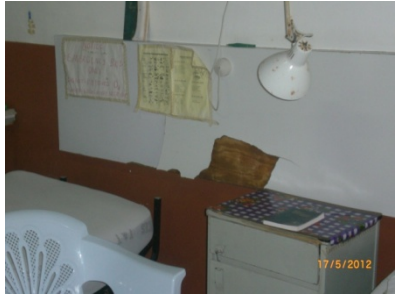
ITEM NO.	AREA/ROOM	ITEM DESCRIPTION (DEFECT, ISSUE)	SCOPE OF WORKS REQUIRED	COST BENEFIT
				PHOTOGRAPHS AS ATTACHED AS GUIDE
10	Interior Furnishings Hospital	<p>Defect:</p> <ul style="list-style-type: none"> Damaged Non-hygienic Lack of storage capability <p>Issue:</p> <ul style="list-style-type: none"> Some of the countertops and cabinets in the kitchen, sluice, sterilization rooms etc. show signs of water damage and lack shelving and storage space. 	<p>Works Required:</p> <p>General</p> <ol style="list-style-type: none"> Remove and replace all countertops and cabinets in the Examination Room, Casualty Room, Sterilization Room and Sluice Room as specified in drawings. Refurbish and make good all existing countertop and cabinets in the Nurse-In charge Room and Kitchen as specified. Install new shelving racks in the newly located file /storage room as specified. Refurbish existing Nurses station counter with new Formica surface. Remove existing hanging bed screen curtains from all Wards and replace with new privacy beds screen curtains on tracks with hanging rails and hardware for its installation. Refurbish existing wall mounted headboards in all Wards with new Formica surface and make good all electrical installations of receptacles (220,110v) and over bed head light fixtures with switches. <p>Specifications:</p> <ol style="list-style-type: none"> All new and existing countertop surfaces shall be replaced with Corian type surfaces for Healthcare facilities (see drawings for dimensions and other specifications). All refurbish and new cabinet surfaces shall be replaced with Formica High Pressure Laminate (HPL) surfaces (see drawings for dimensions and other specifications). Shelving to be installed in the new file/storage room shall be heavy duty record and equipment storage racks (see drawings and appendix for specifications). Nurses station counter shall be refurbished with Formica High Pressure Laminate (HPL) surfaces (see drawings for dimensions and other specifications). Refurbish headboard for beds within all Wards shall be installed with Formica High Pressure Laminate (HPL) surfaces (see drawings for dimensions and other specifications). <p>All color scheme and pattern to be approved by Project Manager.</p>	<p>Benefit:</p> <ul style="list-style-type: none"> To improve the durability and hygiene of all countertops surfaces. To improve the rooms storage capacity. To improve the patients/staff satisfaction by providing more privacy and convenience. <div style="display: flex; flex-direction: column; align-items: center;">

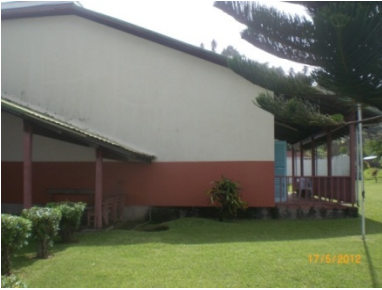
ITEM NO.	AREA/ROOM	ITEM DESCRIPTION (DEFECT, ISSUE)	SCOPE OF WORKS REQUIRED	COST BENEFIT
				PHOTOGRAPHS AS ATTACHED AS GUIDE
11	<p>Wall Finishes- Exterior and Interior Walls of both the Clinic and Hospital.</p> <p>Hospital and Clinic</p>	<p>Defect:</p> <ul style="list-style-type: none"> Fading, Peeling and moss/mold growth on the exterior walls <p>Issue:</p> <ul style="list-style-type: none"> Due to the lack of a guttering system on the main roof of the buildings, there are areas where the exterior wall surfaces on the clinic and hospital are heavy with moss/mold growth and the fading/peeling of the paint on the exterior walls. 	<p>Works Required:</p> <ol style="list-style-type: none"> Scrape and/or power wash all exterior and interior wall surfaces with moss/mold removing solution prior to paint applications. Re-paint walls as specified with moss/mold resistant exterior primer and paint. <p>Specification:</p> <ol style="list-style-type: none"> All paint installations and disposal shall in accordance to the Manufacturers specifications and in strict compliance with local and international building regulations and guidelines. Use paints that meet all three of the following health requirements should be used: low VOCs, low biocides, and natural pigments. All exterior paints have fungicides, and low-biocide paints are not available for exteriors. The desired choice for exterior paint is one that has zinc oxide as the fungicide. Next best choices are zero to very low-VOC paints, acrylic or latex paints, and recycled water-based paint. Milk paint and natural paints are the first choice for commercially available interior paint. Avoid oil-based paints because of their high VOC content. Also, use light colored paints. The choice of color must be approved by the Project Manager. 	<p>Benefit:</p> <ul style="list-style-type: none"> To provide and maintain a healthier, moss/mold free use environment. Improve morale of staff and present a clean appearance to the public. It will also compliment the completion of the new dialysis building and enhance the aesthetics of both buildings. <p>East Facade Of Hospital</p>

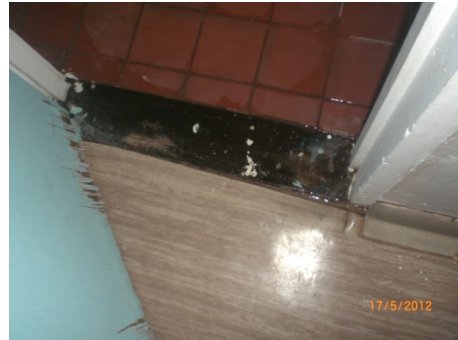
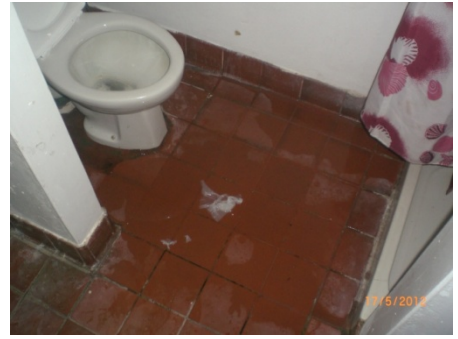
ITEM NO.	AREA/ROOM	ITEM DESCRIPTION (DEFECT, ISSUE)	SCOPE OF WORKS REQUIRED	COST BENEFIT
				PHOTOGRAPHS AS ATTACHED AS GUIDE
12	Floor Finishes Hospital	<p>Defect:</p> <ul style="list-style-type: none"> Water Damaged and worn <p>Issue:</p> <ul style="list-style-type: none"> The flooring in the restrooms is water damaged and is in poor condition with mildew settling between the grout lines. The existing linoleum flooring is worn and has water settlement and damage underneath its sections. 	<p>Works Required:</p> <p>General</p> <ol style="list-style-type: none"> Remove all existing Linoleum floor surfaces and floor base vinyl strips. Make provision to remove excess adhesive from floors and power wash to clean (See drawings for locations). Replace all existing floor tiles in the restrooms, kitchen, store rooms, verandas and other designated areas with non-skid sustainable floor tiles. Make provisions to jack hammering tiles free from surfaces and make surface good for new application. Replace existing linoleum floor covering with higher grade linoleum sheets or tiles (See drawings for locations). <p>Specification:</p> <ol style="list-style-type: none"> All flooring installations shall in accordance to the Manufacturers specifications and in strict compliance with local and international building regulations and guidelines. Linoleum is a homogenous floor covering made primarily of natural ingredients that include linseed oil, rosin binders, wood flour, limestone and dry pigments which are mixed and then calendared onto a polyester backing to ensure optimum dimensional stability. They should meet the following: <ul style="list-style-type: none"> Static Load Limit: 1500 Pounds per square inch when tested in accordance with ASTM F 970-00, Standard Test Method for Static Load Limit. Slip Resistant Castor Resistant: Suitable for office chairs with castors Impact Sound Reduction: 6db when tested in accordance with ISO 20717-2 Resistant to Bacteria Fire Testing: Resists cigarette burns. Chemical Resistant Restrooms, kitchen, all verandas and other designated areas shall use anti-skid ceramic floor tiles especially in heavy traffic areas. The choice of color and pattern must be approved by the Project Manager. 	<p>Benefit:</p> <ul style="list-style-type: none"> Sustainable, recyclable, biodegradable product with anti microbial properties. Improves hygiene which is a top priority. <p>Water Damaged Floor in Hospital</p>

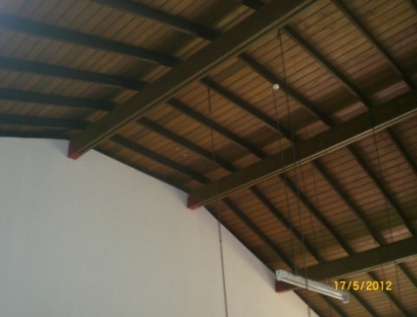
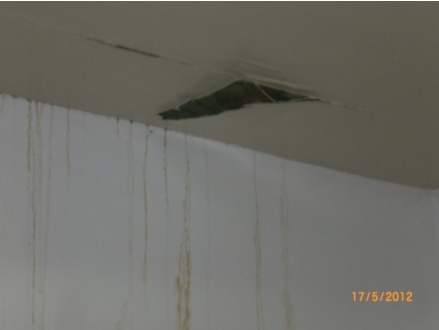
ITEM NO.	AREA	ISSUE	SCOPE OF WORKS REQUIRED	COST BENEFIT
				PHOTOGRAPHS IF NECESSARY OR APPLICABLE
13	Ceiling Finishes Hospital	<p>Defect:</p> <ul style="list-style-type: none"> High ceilings; lack of accessibility to light fixtures Water/Mould damage Bat droppings on ceilings <p>Issues:</p> <ul style="list-style-type: none"> The high ceilings has diminished the potential radiation from the suspended lighting and the installation of proposed ceiling fans will limit its functionality and decrease ventilation throughout the ward spaces. Access to the lights and proposed fans for maintenance purposed will be difficult and unsafe. The low ceiling areas (restrooms and child birth/delivery room) has some water damage and has signs of mold/mildew growth. There is evidence of rodent (bat) infestation and droppings on tables and along the walls. This problem is minor in the Hospital but major in the kitchen area of the clinic. 	<p>Works Required:</p> <p>General</p> <ol style="list-style-type: none"> Install a drop ceiling mechanism where all lights, ceiling fans and other devises can be accessible (See reflective ceiling plan drawings for details). Replace all drop ceiling in areas as specified in reflective ceiling plans. Properly secure and enclose all openings (big or small) in the ceiling and exterminate any rodents or insects that are present in the building. <p>Specifications:</p> <ol style="list-style-type: none"> All ceiling finishes installations shall be in accordance to the Manufacturers specifications and in strict compliance with local and International building regulations and guidelines. In areas such as the Examination, Casualty, Sluice, Delivery Rooms and other designated areas shall use only National Gypsum Co. Gold Bond brand Grid stone Clean Room Gypsum ceiling panels. Fire rating by type and size shall be Type: 1/2" (12.7mm) Fire-shield G, 2' X 2'; UL G222. (see reflective ceiling drawings for further details) In the high ceiling areas where the existing with new wood rafter and ceiling boards are exposed, make good by treating wood and enhance stain finish. See reflective ceiling drawings for ceiling tile location and mounting details. 	<p>Benefit:</p> <ul style="list-style-type: none"> Improve lighting, functionality of the ceiling fans and ventilation through the spaces. Allow for ease of access to the overhead fixtures and devices during maintenance. Enhance and improve the longevity of the wood rafte and ceiling. Clean room ceiling tiles shall improve the sanitat condition and prevent particle contamination especially in clean room environments. <div style="text-align: right;">

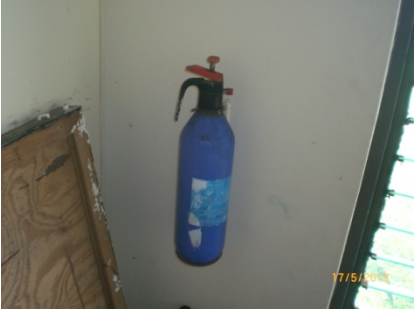
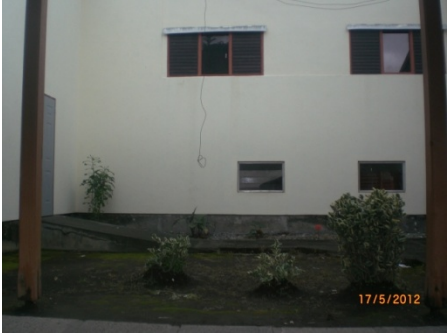
ITEM NO.	AREA	ISSUE	SCOPE OF WORKS REQUIRED	COST BENEFIT
				PHOTOGRAPHS IF NECESSARY OR APPLICABLE
14	<p>Code Compliance</p> <p>Fire/ Smoke Alarms, Emergency Lighting System, Emergency exit signage maps, Fire extinguishers and Handicap accessibility</p> <p>Hospital and Clinic</p>	<p>Defect:</p> <ul style="list-style-type: none"> No fire/smoke detectors and emergency lighting available. No emergency exit signage or maps Outdated and minimal fire extinguishers No handicap accessibility aids. <p>Issue:</p> <ul style="list-style-type: none"> There are no fire/smoke alarms in the kitchens, file rooms or any other room sensitive to fires for both the Hospital and Clinic. In the event of an emergency, power outage or backup generator failure, there are no emergency lights in the hospital and clinic. The staff members only have access to battery powered lanterns which are not reliable. The Hospital/Clinic is equipped with at least one handicap ramp access to the facilities. The ramps size meets code standards; however, it lacks handrails or guardrails. The ramps are also exposed to the elements and tend to get slippery when wet. The shower stalls and toilet areas are not handicap compliant. There are no grab bars within these areas. 	<p>Works Required:</p> <p>General</p> <ol style="list-style-type: none"> All Code Compliance installations shall be in accordance with the Manufacturer's instructions and in strict compliance with the local and international building regulations and guidelines. Install fire/smoke detectors in the kitchen, sterilization room, delivery room and other sensitive rooms prone to fire (See reflective ceiling plan for locations and details) Install Emergency Lights and exit signs in strategic locations as specified in the reflective ceiling/electrical light drawings. Install Evacuation maps as specified. To be provided to the Contractor by the Project Manager for installation. Contractor to provide evacuation map wall frames. Install fire extinguishers in strategic locations as specified. Install and make compliant the handicap ramps with a slip resistant surface to avoid slipping and sliding and handrails. Install grab bars within the shower stalls and toilet areas and install ADA compliant face basins within the restrooms as specified in the restroom detail drawings. <p>Specifications:</p> <ol style="list-style-type: none"> All Fire/Smoke detectors shall be wall or ceiling mounted, double sensor unit with hardwire and battery backup as specified. All Emergency Lighting and exit signs shall be LED lamp type rated units. The exit sign shall be green in colour. The Evacuation Map holders shall be glow in the dark with emergency map labeling. Size map to accommodate will be 11"x 17". All Fire extinguishers shall be ABC rated (multi-purpose) units with a 10 lb. capacity. Make provisions to outline all mounting locations with adequate signage. For electrical rooms, use 10 lb. capacity Carbon dioxide extinguishers. All grab bars are specified in the restroom drawings. All existing and proposed Handicap ramps surfaces shall be outfitted with ECO-TUFF Rubberized Non-Skid safety coating which has zero VOC and ultra tuff and waterproof. All Handicap ramp hand-rails size and design are specified in the drawing details. 	<p>Benefit:</p> <ul style="list-style-type: none"> This will enhance the level of fire safety throughout the buildings and maximize the fire/smoke detection. This will aid in providing adequate lighting in the event of any emergency scenario. To aid in the facilities compliance to safety and risk reduction and staff awareness and development. To aid in the facilities compliance to Handicap accessibility and safety.

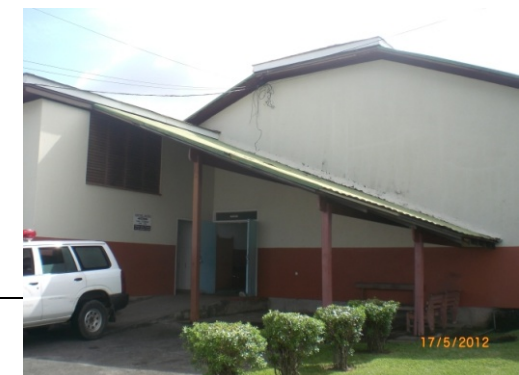
OPTIONAL WORK FOR CONSIDERATION					
ITEM NO.	AREA/ROOM	ITEM DESCRIPTION (DEFECT, ISSUE)	SCOPE OF WORKS REQUIRED	COST BENEFIT	
				PHOTOGRAPHS AS ATTACHED AS GUIDE	
16	Main entrance covering Hospital only	Defect: <ul style="list-style-type: none"> Insufficient sheltering from the elements Vulnerable to wind uplift and hurricane events Water damage to wooden beams and supporting posts Ambulance area lacks sufficient lighting. No public restroom facility for visitors. Issue: <ul style="list-style-type: none"> The existing main entrance doesn't provide sufficient shelter from the elements for visitors and importantly for Ambulance operations. The access ramp used by the Ambulance is exposed to the 	Works Required: General <ul style="list-style-type: none"> Remove existing roof covering over main entrance. Make good masonry works and remove fixed wooden louvers from adjoining wall. Install new concrete roof covering as detailed in drawings to include the realignment of the access ramp, public restroom facility for visitors and raised waiting area platform (see drawings for details). Specifications: <ul style="list-style-type: none"> Roof to be constructed from reinforced concrete as specified in drawings. All other installations in this area shall be conducted in accordance to Manufacturers requirements and in strict compliance with the Local and international building regulations and guidelines. 	Benefit: <ul style="list-style-type: none"> It will improve the safety and efficiency of the Hospital Ambulance To increase the Hospital's resilience to hurricane event and aid in the providing safe access to the main roof for any maintenance purposes.

<p>elements and needs to be relocated for ease of access.</p> <ul style="list-style-type: none">• The existing roof overhang is vulnerable to wind uplift and hurricane events		
--	--	--	--	--
