An Economic Appraisal of a SMART Hospital Initiative: Pogson Medical Centre – St. Kitts Nevis

Mark Bynoe

Caribbean Community Climate Change
Centre

11/29/2013

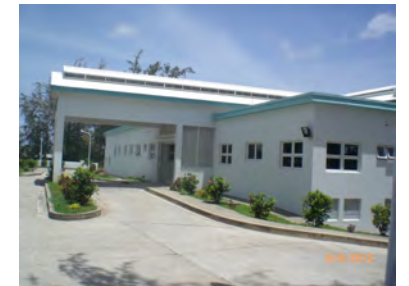
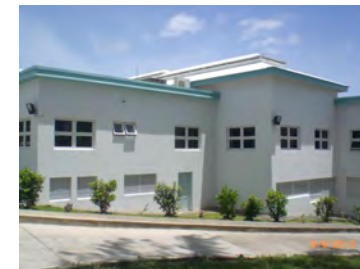
ITEM NO.	AREA/ROOM	ITEM DESCRIPTION (DEFECT, ISSUE)	SCOPE OF WORKS REQUIRED	COST BENEFIT
				PHOTOGRAPHS AS ATTACHED AS GUIDE
2	Roof Works	<p>Defect:</p> <ul style="list-style-type: none"> The main entry roof is very vulnerable to wind uplift. Water damage and fading of the concrete parapet walls and to fascia boards. <p>Issue:</p> <ul style="list-style-type: none"> No access is available to the roof of the facility; No ladder available. The hip and gable roof sections have four (4) roof vents along the ridge beam of the roof. They are prone to water intrusion under high wind conditions. Visually, there is cracking, peeling of paint and water damage along the concrete drain parapets. The gable and hip roof sections have no guttering to control or capture the water flow off the roofs. The concrete roof sections may be at risk of cracking. 	<p>Works Required:</p> <p>General</p> <ol style="list-style-type: none"> Install a heavy duty aluminum retractable wall mounted access ladder to north side of the building. This is to be installed along the concrete roof sections and provide ease of access to the roof. Replace any damaged or badly corroded hurricane clips at all wood rafter and beam connections. Make provisions to repair or replace any damaged or corroded roof sheeting, flashing, or fastener. Make good any damages to ceiling boards, wood rafters or fascia boards (if necessary). Replace any damaged or missing insect screens located at the four (4) roof vent sections on the hip and gable roof sections. Make provisions to apply waterproofing seal with mold and mildew resistant silicone if necessary. Repair all water damaged parapet wall/drains and clear all drains of debris. Repaint and make good all parapet walls with same color paint as specified in Item No.11 – Wall finishes. Make provisions to clean and apply concrete roof surface with high quality waterproofing compound. (See roof drawings for location and concrete roof square footage). Install a water guttering system on the hip and gable roof sections to control the flow and harvest rain water. <p>Note: Gutters are to be installed along the south and west side (outer side) of the hip roof section and diverted to the proposed 300 gallon water storage tank on the south side of the building.</p> <p>Gutters are to be installed on the inner side of the hip roof section and on the gable roof section (main entry) and diverted to the concrete roof drains.</p>	<p>Benefit:</p> <ul style="list-style-type: none"> To address any water damages to the exposed concrete roof, fascia board and parapet walls. To eliminate the infestation of insects by repairing or replacing insect screens. To minimize the wind uplift vulnerability on the roof and maintain its structural integrity. To ensure effective capture of rain water for use and to control the flow of water to drains to minimize erosion of soil around the building. To maintain the roof's integrity to accept the solar panel for the proposed Photo Voltaic (PV) system. To reduce the transfer of heat radiation through the concrete roof sections into the building.

- a) All roofing material installation shall be conducted in accordance with the Manufacturers requirements and in strict compliance with the Local and International building regulations and guidelines.

- d) For any roof sheeting or flashing replacement, use 24 gauge pre-painted galvalume to match existing profile and colour with matching fasteners and flashing.

- f) Concrete roof waterproofing compound must be a flexible, U.V. resistant elastomeric compound that is designed for all roofing and flashing applications. It must provide a long lasting, energy efficient surface.

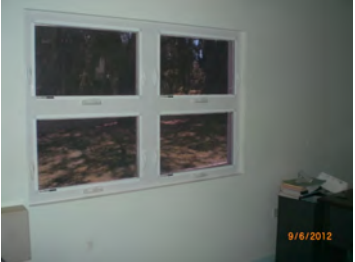
Windows in the X-Ray room

3	Windows Hospital & Healthcare section	Defect: <ul style="list-style-type: none"> Some windows are inoperable; window mechanism needs to be repaired or replaced. Window in x-ray room is not lead lined to minimize radiation exposure. Issue: <ul style="list-style-type: none"> Some of the windows are inoperable and require window mechanism replacement or repair. Windows are only tinted on the north (healthcare) side of the building. There is no tint or solar protection on the three (3) other sides of the building. Windows in the x-ray room poses a high risk of radiation penetrating the room. 	Works Required: General <ol style="list-style-type: none"> Inspect all windows and make repair to any damaged windows or window mechanism. Make provisions to properly waterproof and insulate all window sills and encasements with silicone. Install new non-reflective solar protective window films to all windows. X-ray Room <ol style="list-style-type: none"> Remove existing window in room and enclose opening with cinder blocks. Fill all block cores with concrete and restore wall plastering and paint finish to both interior and exterior surfaces. Specifications: <ol style="list-style-type: none"> All window installation and repairs shall be conducted in accordance to Manufacturers requirements and in strict compliance with the Local and International building regulations and guidelines. Use mold and mildew resistant silicone for waterproofing seal to all windows. Window film shall be Solar Gard window films or equal substitute that provides low emissivity, maximum protection from solar heat and blocks up to 99% of UV rays. 	Benefit: <ul style="list-style-type: none"> To improve ventilation and provide an increase level of security. To eliminate water intrusion through the windows during high wind and heavy rain events. It will show potential savings on the energy bill by keeping the building cool. It will provide solar heat and glare protection for improved comfort It will provide protection by holding shards of glass together if broken Protects employees, patients and property from damaging ultraviolet rays. Removal of window will eliminate the exposure and leakage of radiation from the X-ray room. Windows on the Healthcare side of the facility

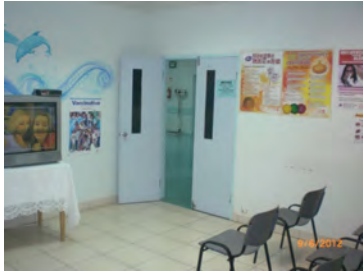
<p>Generator Housing Doors to be replaced</p>

NO.		(DEFECT, ISSUE)		PHOTOGRAPHS AS ATTACHED AS GUIDE
4	<p>Doors: Interior and Exterior</p> <p>Hospital & Healthcare section</p>	<p>Defect:</p> <ul style="list-style-type: none"> Some exterior doors have termite damage and lack sufficient security and safety features <p>Issue:</p> <ul style="list-style-type: none"> The doors at all designated emergency exits are not adequately fire rated. They also lack security features and have no panic bar mechanism. Some exit doors swing direction is inappropriate and require adjustment. The facility is equipped with a key pad security system to most entry/exit doors. One code is used by staff to access all doors throughout the entire facility. Some interior doors strategically require a security lock mechanism to prohibit unauthorized access from the healthcare area to the hospital area. The louvered double doors at the emergency generator housing are termite damaged and require replacement with fire rate doors. The door at the x-ray room may not be adequately lead lined to minimize radiation exposure and leakage. 	<p>Works Required:</p> <p>General</p> <ol style="list-style-type: none"> Remove all designated emergency exit doors and make good all openings. Install (No. 7) new emergency exit doors with fire rated exit doors, panic mechanism and steel reinforced glass sash with door closures. (See floor plan and door schedule for exterior door type, quantity and location). Replace the existing key pad security system with a swipe card security system and make good all connections to emergency exits and designated interior doors (See Item no.14 – Code compliance for more information). Install new security (swipe card) lock mechanism to no. 2 existing interior doors to prohibit unauthorized access. (See floor plan for designated doors to be retrofitted). Remove two (2) existing 6'-0" double wooden louvered doors and jambs at the emergency generator housing and replace with pre-hung metal, fire rated louvered doors with jambs, heavy duty hinges and hardware (See door schedule for more information). Assess the existing door of the x-ray room for lead lined radiation compliance. If non-compliant, replace door with new pre-hung lead lined door and frame with hardware and door closure as specified. Make provisions to adjust door swing directions and replace door jambs; equip all doors with heavy duty door closures. <p>Specifications:</p> <ol style="list-style-type: none"> All doors and security installations shall be conducted in accordance to Manufacturers requirements and in strict compliance with the Local and International building regulations and guidelines. For all door sizes, quantity and retrofit specification, see floor plan drawings and door schedule for more information. Lead lined door for the x-ray room must be pre-hung and fire rated with hardware and door closure. It is mandatory that the contractor comply with the Manufacturer's instructions for receiving, handling, storing and protecting of such materials. Standard lead doors are manufactured with lead thickness of less than 0.25 inches. 	<p>Benefit:</p> <ul style="list-style-type: none"> To improve the facility's level of safety, egress accessibility and security. To eliminate the exposure and leakage of radiation from the X-ray room. <p>Interior Door in Hospital waiting area to receive swipe card access</p>

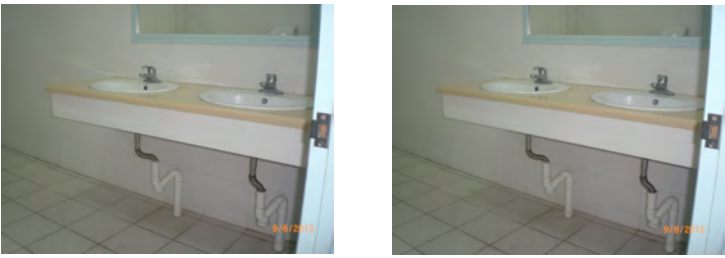
<p>Condition of Sluice Sink</p>

- a) Remove existing built in place sluice tub and tank assembly from location.
- b) Install new stainless steel sluice unit with cistern tank and install new aerated faucet with antimicrobial handles. Include wall mounted storage racks for bed pans.
- c) Make provisions to repair or replace all traps, shut off valves, fittings and re-caulk areas with mold and mildew resistant silicone if necessary

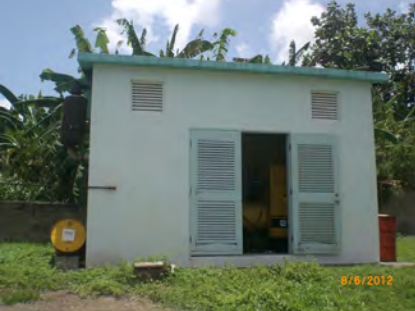
<p style="text-align: center;">Diesel Storage tank for emergency generator</p>

NO.		(DEFECT, ISSUE)		PHOTOGRAPHS AS ATTACHED AS GUIDE
7	<p>Electrical Works – Emergency Power Supply</p> <p>Hospital & Healthcare section</p>	<p>Defect:</p> <ul style="list-style-type: none"> Battery supply faulty <p>Issue:</p> <ul style="list-style-type: none"> The battery supply to the generator may be faulty and may require replacement. The diesel storage tank for the generator is not properly anchored to its foundation and its supply line is unsafely suspended to the generator housing. There is no spill over protection in the event of diesel fuel spills. The electrical meter for the facility is inside of the generator housing. It should be relocated, sheltered and mounted on the outside wall of the generator housing for ease of access by the electrical company. 	<p>Works Required:</p> <p>General</p> <ol style="list-style-type: none"> Conducts an assessment of the emergency generator engine, main disconnect switch and all other electrical components. Make provisions to allow for minor engine repairs or replacements, maintenance works, electrical items and equipment and for any necessary trenching, concrete surroundings, sand bed earthing support and electrical service installations. Also include termite treatment for the housing. Refurbish existing diesel storage tank by removing all diesel fuel residue, treat all rust spots, reinforce all seals and repaint. Fuel storage tank must be properly anchored to its concrete supports. Construct a fuel spill-over catchment beneath the fuel storage tank as specified. Make provisions to repair any damages to the existing fuel line, its connections and fuel valve. Also reinforce the connecting fuel line (suspended) between the storage tank and the generator housing. <p>Specifications:</p> <ol style="list-style-type: none"> All Electrical installations shall be in accordance with the Manufacturers specifications and in strict compliance with local and international building regulations and guidelines. The exterior door shall be (no.2) pre-hung fire rated metal doors with fixed louvers to allow for ventilation. It must be equipped with heavy duty corrosion resistant handles, knobs and hinges. Width of doors should be 6’ -0”. Contractor to verify opening of existing door height. The interior lighting shall be energy efficient LED light bulbs with heat resistant industrial fixture covers. Fuel spill-over catchment area must be at least 8’-0” L X 8’-0”W X 8” D or sized to accommodate at least 40 cubic ft. or 1.5 cu. yards of sand. Catchment base must be made of 4” thick concrete slab reinforced with BRC wire mesh. Use 6” concrete blocks as parapet walls with ½” steel bars at 16” o/c. Fill all block cores and provide plaster finish to block wall surfaces. Catchment area should be centered of the existing storage tank support columns. 	<p>Benefit:</p> <ul style="list-style-type: none"> To provide a reliable, back-up supply of electricity to the facility when the public supply and the PV system are down. To improve the generator efficiency through improved ventilation and increase its life cycle. To protect the environment of any ground contamination from fuel spills. <p style="text-align: center;">Emergency Generator & Housing</p>

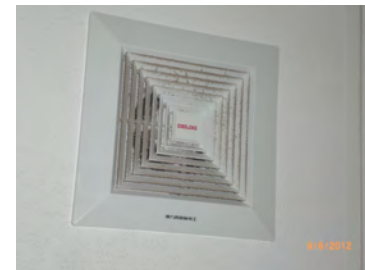
Exhaust fan in restroom not working

- All exhaust fans shall be replaced with quiet motion, energy star rated units (See drawings for location).
- The exhaust hood must be placed over the existing Vulcan 6 burner commercial grade stove with a commercial grade, energy rated range hood with a stainless steel finish to compliment stove. Make provisions for cutting holes, ducts, exhaust fans and any electrical and cabinetry works.

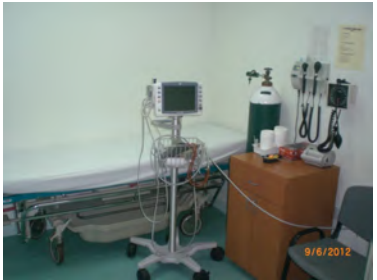
Oxygen tanks in storage room and treatment rooms unsecured

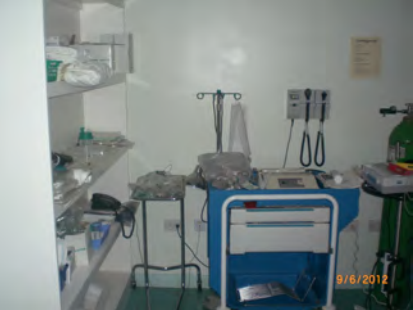
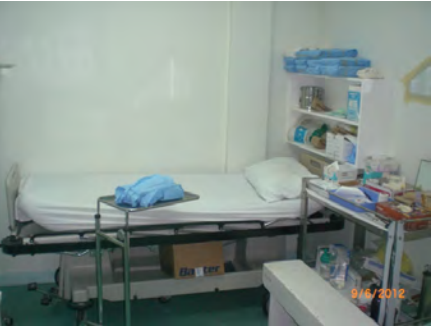
ITEM NO.	AREA/ROOM	ITEM DESCRIPTION (DEFECT, ISSUE)	SCOPE OF WORKS REQUIRED	COST BENEFIT
				PHOTOGRAPHS AS ATTACHED AS GUIDE
10	Interior Furnishings Hospital & Healthcare section	<p>Defect:</p> <ul style="list-style-type: none"> Shelving units not secured <p>Issue:</p> <ul style="list-style-type: none"> All storage and shelving units that stores medical files, medications, medical supplies and medical equipment are not properly secured 	<p>Works Required:</p> <p>General</p> <p>a) Retrofit all storage cabinets and shelves with shock cord restraints as specified.</p> <p>Specifications:</p> <p>a) Shelf and cabinet restraints shall be outfitted to all unsecured shelves and storage cabinets. The rooms will include the pharmacy, triage, all treatment rooms, nurse's station, labor & delivery room, administrations & records, clean and medication rooms, etc. Some rooms or areas may use restraints like high-friction, non-adhesive cut-to-size PVC foam mats' double grip, on both the shelf and its contents to prevent movement.</p> <p>b) In areas such as pharmacy storage shelves or overhead bookshelves, it will be most effective to use high-quality Bungee cord that is stretched taut by plastic connectors at either end to restrain shelf contents. The cord's holding power is enforced by aluminum tubing. The bar-like cord swings up easily for convenient access.</p>	<p>Benefit:</p> <ul style="list-style-type: none"> To improve the safety and resilience of the facility against earthquakes. <p>Unsecured shelving units in the Triage and Treatment Rooms</p>

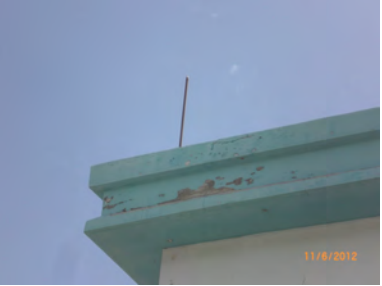
ITEM NO.	AREA/ROOM	ITEM DESCRIPTION (DEFECT, ISSUE)	SCOPE OF WORKS REQUIRED	COST BENEFIT
				PHOTOGRAPHS AS ATTACHED AS GUIDE
11	<p>Wall Finishes- Exterior and Interior Walls</p> <p>Hospital & Healthcare section</p>	<p>Defect:</p> <ul style="list-style-type: none"> Fading, Peeling and moss/mold growth on walls <p>Issue:</p> <ul style="list-style-type: none"> The paint on the parapet walls of the facility is fading and peeling. Some interior and exterior wall surfaces are dirty and fading. 	<p>Works Required:</p> <ol style="list-style-type: none"> Touch up exterior and interior wall surfaces that are fading, peeling or dirty with moss/mold resistant paint. Use same color paint on building. Make provisions to scrape and clean all wall surfaces prior to painting. Touch up all exposed wood rafter ceilings if necessary. <p>Specification:</p> <ol style="list-style-type: none"> All paint installations and disposal shall be in accordance with the Manufacturers specifications and in strict compliance with local and international building regulations and guidelines. Use paints that meet all three of the following health requirements should be used: low VOCs, low biocides, and natural pigments. All exterior paints have fungicides, and low-biocide paints are not available for exteriors. The desired choice for exterior paint is one that has zinc oxide as the fungicide. Next best choices are zero to very low-VOC paints, acrylic or latex paints, and recycled water-based paint. Milk paint and natural paints are the first choice for commercially available interior paint. Avoid oil-based paints because of their high VOC content. Also, use light colored paints. 	<p>Benefit:</p> <ul style="list-style-type: none"> To provide and maintain a healthier, moss/mold free use environment. Improve morale of staff and present a clean appearance to the public. <p>Fading/Peeling parapet wall on roof of the facility</p>

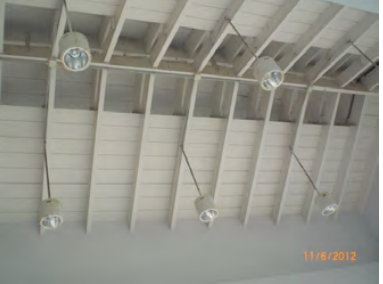
<p>Exposed wood rafters at main entrance</p>

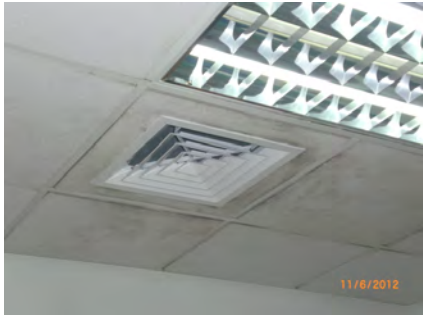
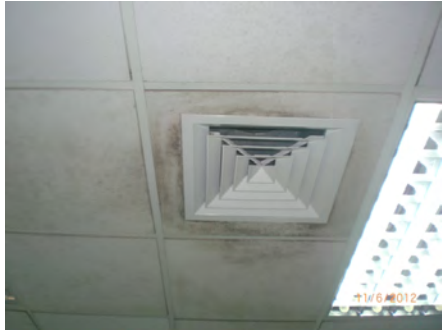
ITEM NO.	AREA	ISSUE	SCOPE OF WORKS REQUIRED	COST BENEFIT
				PHOTOGRAPHS IF NECESSARY OR APPLICABLE
13	Ceiling Finishes Hospital & Healthcare section	Defect: <ul style="list-style-type: none"> Water/Mold damage on ceiling tiles Issues: <ul style="list-style-type: none"> The ceiling tiles at the central air condition supply vents have water damage and shows signs of mold/mildew growth. 	Works Required: General <ol style="list-style-type: none"> Replace all missing or damaged drop ceiling tiles in areas that are water damaged and showing signs of mold growth. Install water and mold resistant ceiling tiles to all air supply and return vent locations as specified. Specifications: <ol style="list-style-type: none"> All ceiling finishes installations shall be in accordance with the Manufacturers specifications and in strict compliance with local and International building regulations and guidelines. All air supply inlets and return vents must be installed with 2'x2' water and mold resistant ceiling tiles in all locations. 	Benefit: <ul style="list-style-type: none"> To improve the indoor air quality and maintain a mold free environment.

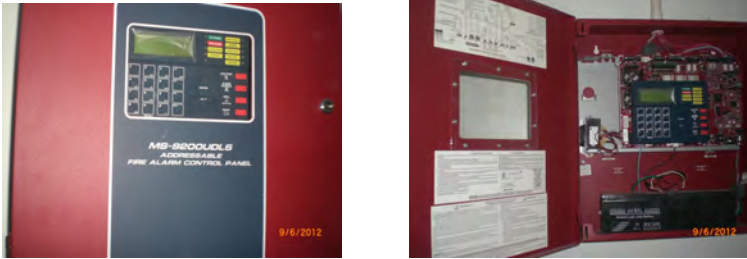
</div> <p style="text-align: center;">Existing fire extinguishers</p> <div style="text-align: center;">

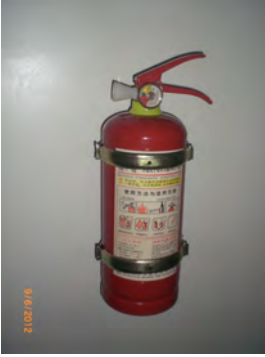
</div> <p style="text-align: center;">Fire hose assembly</p>

construction and impregnable against abrasion. Must meet a service life of not less than 5 years. Water valve and hose fittings must be compatible with local fire department appliances and equipment.

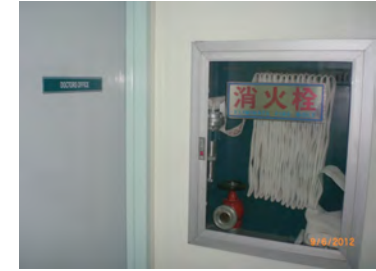
Emergency exit doors with signs

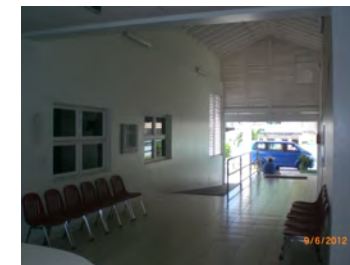
Disability access ramps

- f) All existing Handicap ramps and emergency access staircase surfaces shall be outfitted with ECO-TUFF Rubberized Non-Skid safety coating which has zero VOC and ultra tuff and waterproof.

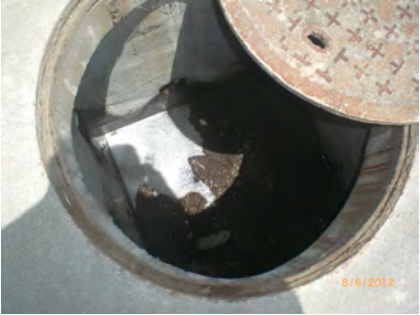
NO.		(DEFECT, ISSUE)		PHOTOGRAPHS AS ATTACHED AS GUIDE
15	<p>External Works- Drains, Landscaping</p> <p>Hospital & Healthcare section</p>	<p>Defect:</p> <ul style="list-style-type: none"> • Drains are filled with debris. <p>Issue:</p> <ul style="list-style-type: none"> • There is no clear marking to differentiate between storm drain manholes and sewer manholes. • The storm drains and pipes are filled with mud and debris and needs to be flushed. • The landscape on the western side of the facility needs to be graded properly to avoid water runoff into the ground floor of the building. 	<p>Works Required:</p> <p>General</p> <ol style="list-style-type: none"> Flush out all mud and debris out of all storm water drains and pipes. Level and grade (western side) landscape away from the facility to prevent potential flooding of the lower ground floor. <p>Specifications:</p> <ol style="list-style-type: none"> Any contact with contaminated water or sludge from the drains must be safely transport and disposed off-site. Make provisions for any ground works, drain pipe repairs or installations. 	<p>Benefit:</p> <ul style="list-style-type: none"> • It will improve the drainage of the landscape and eliminate any potential flooding of the facility. <p>Condition of the Storm water drain</p>

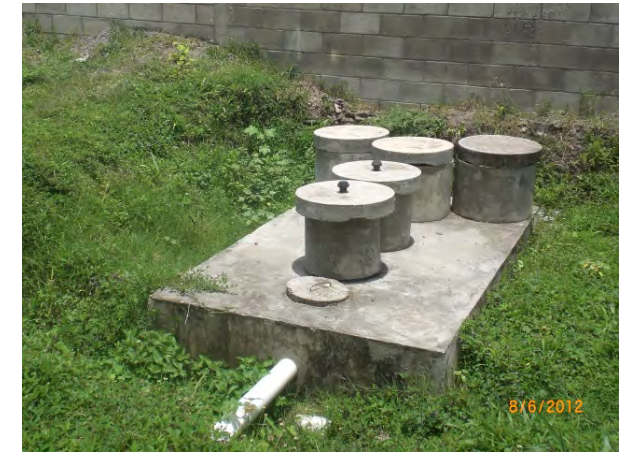
<p>16</p>	<p>Sewerage Treatment</p> <p>Hospital & Healthcare section</p>	<p>Defect:</p> <ul style="list-style-type: none"> • Non-operational. <p>Issue:</p> <ul style="list-style-type: none"> • The facility is equipped with a wastewater treatment system but it is incomplete. • The sewer manholes are incomplete and require proper hunching of their bases to allow smooth transition or flow of sewage from the sewer lines to the wastewater treatment plant. 	<p>Works Required:</p> <p>General</p> <ol style="list-style-type: none"> Complete and commission the existing wastewater treatment system. Include the installation of a treated effluent storage tank and a drip irrigation system to be incorporated into the landscape. Conduct an assessment of all sewer pipes, pipe inverts and manholes. Make provision to include any ground works, pipe works, concrete works and manhole repair and installations. <p>Specifications:</p> <ol style="list-style-type: none"> The sewerage treatment is manufactured by Norweco Wastewater Equipment Company. Type system: Singulair Bio-Kinetic wastewater treatment system. Local distributor is J&S Environmental Services Ltd. P.O. Box 346 Basseterre, St. Kitts. Installations shall be in accordance with the Manufacturers specifications and in strict compliance with local and international building regulations and guidelines. Handles odor control and filamentous bacteria; stabilizes the plant, improves settling rate of Biomass, good quality of treated water. Specifically the system should allow for the following: <ul style="list-style-type: none"> • Up to 95% reduction in Biochemical Oxygen Demand & 90% reduction in Chemical Oxygen Demand load. • Maximum odor control • Generates minimum sludge • Consist of various specialized microbial culture and enzymes which can digest even complex organic compounds. • Can handle toxic loads. • Can handle hydraulic loads • Cultures grow in either the presence or absence of oxygen. • Low treatment cost. Increases efficiency of the sewage treatment plant and saves energy costs. • Sewage treated with can be reused for irrigation purposes or recharging ground water. • Non-corrosive, non-pathogenic and low quantities of use, making it safe and easy to handle and store. 	<p>Benefit:</p> <ul style="list-style-type: none"> • The system will properly treat and reuse all the sewerage water from the facilities and circulate the treated water through a drip irrigation system into the landscape. • It will minimize the overflow and pumping of sewerage and eliminate the exposure of sewerage water flowing through open drains.
