# THE RADIOLOGICAL ACCIDENT IN SAN SALVADOR

A REPORT PREPARED BY IAEA IN CO-OPERATION WITH PAHO/WHO

INTERNATIONAL ATOMIC ENERGY AGENCY, VIENNA, 1990

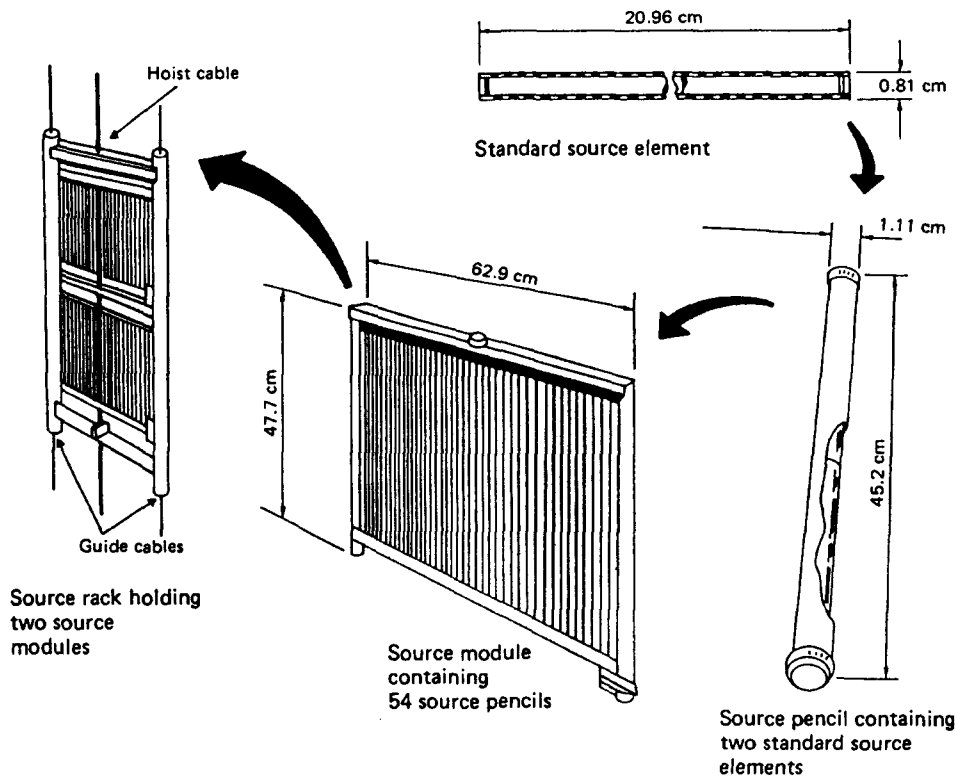
FIG. 5. The source rack with two source modules, each containing up to 54 source pencils with two standard source elements in each pencil. (By courtesy of Nordion International Inc.)

Radioactive cobalt-60 metal is the radiation source in the JS6300 Gamma Sterilizer. The cobalt-60 source elements are contained in doubly encapsulated stainless steel source pencils approximately 45 cm long, with solid stainless steel end caps approximately 1 cm in diameter (see Fig. 5). Each source pencil is identified by a

serial number engraved on an end cap. Fourteen active source pencils and 40 inactive dummy pencils (stainless steel spacer rods) were loaded into each of two source modules. The source pencils and dummy pencils are held in place in channels at the top and bottom of the source modules. The two source modules are placed one above the other in a flat, vertical source rack to give a uniform radioactivity over an area approximately 0.60 m by 0.90 m. When the source was installed in June 1975 the total radioactivity of the cobalt-60 gamma source was 4.0 PBq (108 kCi). By the time of the accident (5 February 1989) its radioactivity had declined to 0.66 PBq (18 kCi).

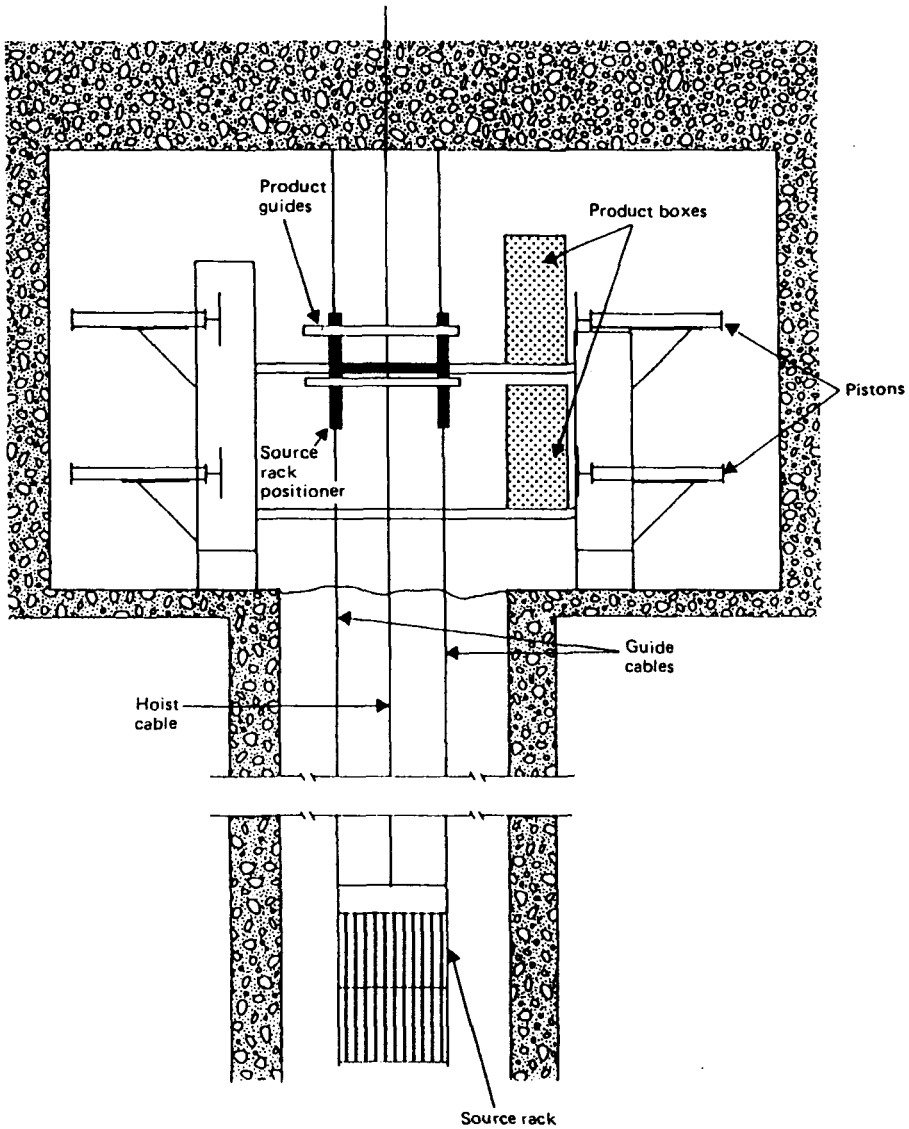
FIG. 6. Cross-sectional diagram of the source rack, hoist mechanism and transport mechanism. (By courtesy of Nordion International Inc.)

The source rack, when not in use, is stored near the bottom of a 5.5 m deep storage water pool and is raised to the irradiation position by a pneumatic hoist mounted on the roof of the facility above the radiation shield (see Figs 3 and 4). A stainless steel hoist cable attached to the source rack passes through the shield and the roof to two sets of sheaves in the hoist cylinder. When air pressure is applied to the hoist, the sheaves separate and the source rack is lifted. The movement of the source rack is guided by two taut guide cables, one at each end of the rack. In the raised position the source rack (see Fig. 6) actuates a microswitch to indicate that the source is up.

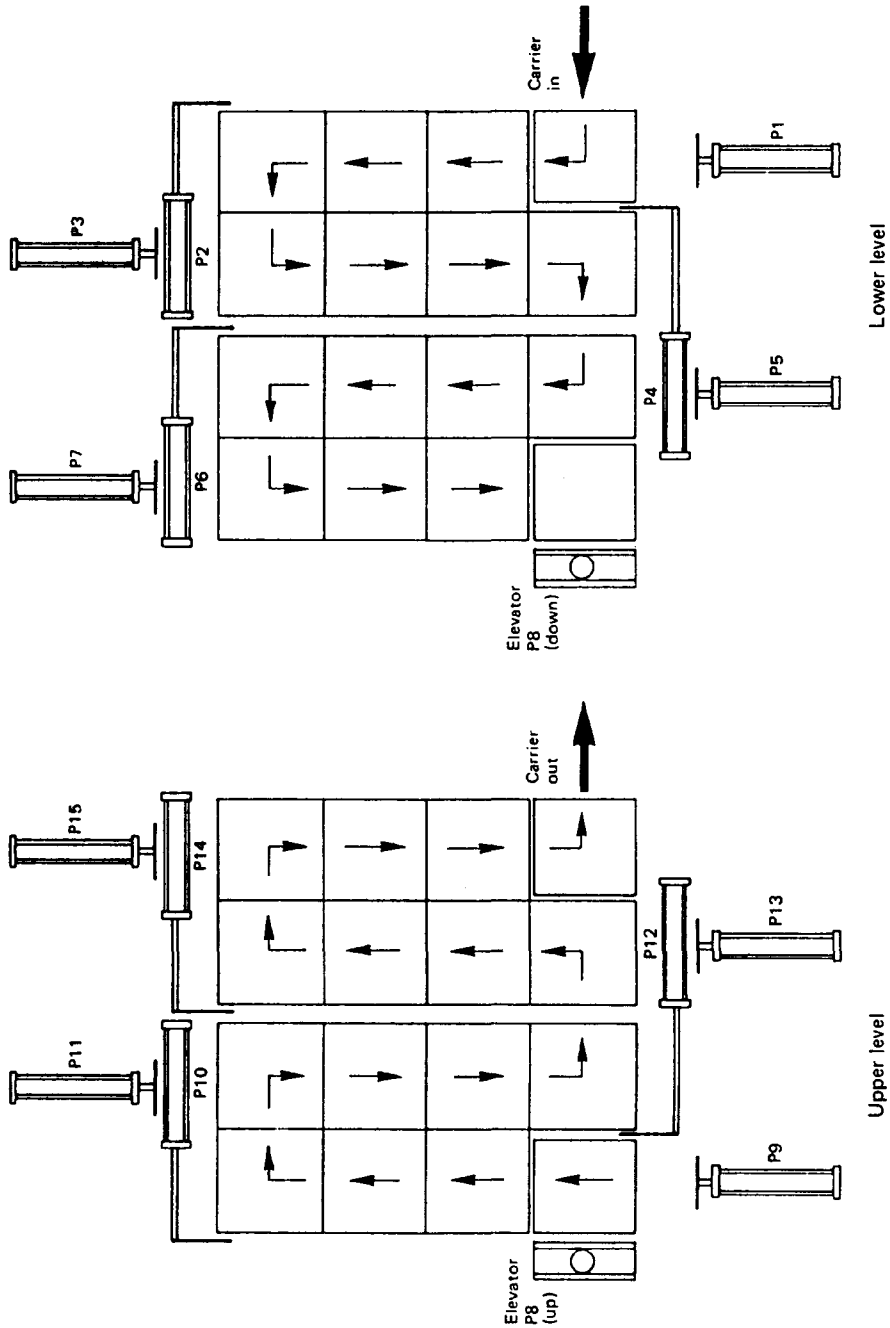
FIG. 7. Plan of the two levels of the transport mechanism of the JS6300 irradiator. (By courtesy of Nordion International Inc.)

In the JS6300 irradiator, the products to be sterilized are loaded into fibreglass product boxes 0.40 m square and 0.90 m high. These boxes on stainless steel trays are irradiated in 29 positions, between which they are moved by pistons of the product transport mechanism (see Fig. 7). The boxes are moved backwards and forwards past the source rack along four rows, two on each side of the source rack, on each of two levels (shown schematically in Fig. 8), and are raised from the lower to the upper level by a pneumatic elevator. Steel product guides restrict the movement of the boxes to the path around the source and provide some protection to the source rack. Limit switches monitor the locations of the boxes and control the sequence of operation of the pistons.

Between 1975 and 1981, a number of incidents occurred at irradiators from the same supplier, in the USA and elsewhere (including the incident in San Salvador in 1975) in which damaged product boxes obstructed the source rack and caused it to jam. Consequently, in 1981, the supplier distributed *Warning Notice IND-81-1*,

*The owner of the plant received this warning notice but never had its recommendations implemented owing to their cost and the increase in the exposure time that would be necessary to compensate for the shielding effect of the shroud. By the time of the accident in February 1989, the product boxes had been in use for a number of years. Many were in extremely poor condition and had been repaired with adhesive tape.*

in which it recommended that a steel source shroud be fitted around the irradiation position. It was also recommended that the condition of the boxes be routinely checked and that boxes in marginal condition be replaced.

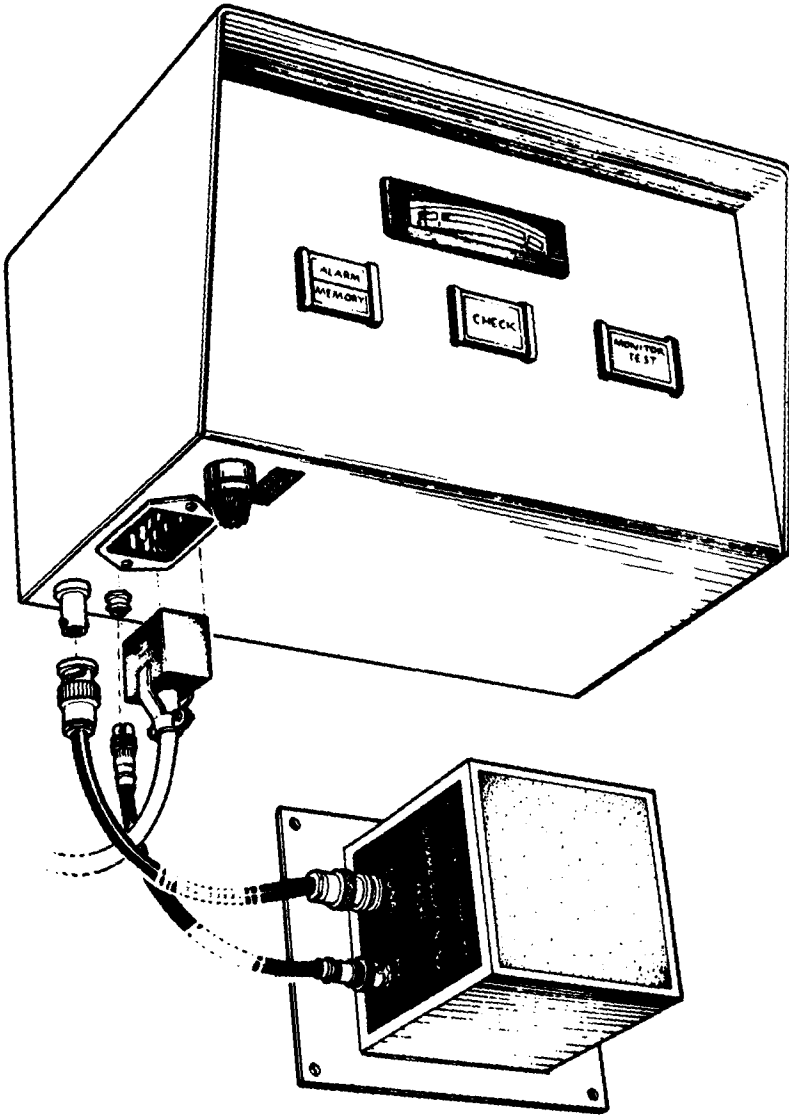
*FIG. 10. The L118 wall mounted single probe monitor system. (By courtesy of Nordion International Inc.)*

An L118 radiation monitor is interlocked with the personnel access door to prevent access to the radiation room if there are abnormal radiation levels inside when the source should be in the storage position. The L118 radiation monitor (see Fig. 10) is mounted on the wall in the radiation room and detects background radiation with a high sensitivity by means of an array of nine Geiger-Müller tubes. The monitor is designed to give an alarm condition for exposure rates in the range from the equivalent of about eight times that due to natural background radiation to greater than  $10\,000\text{ Sv}\cdot\text{h}^{-1}$  ( $10^6\text{ rem}\cdot\text{h}^{-1}$ ). Figure 11 is a schematic representation

*More than five years before the accident, the monitor probe had failed and the probe assembly had been removed. Its cabling remained. Removal of the monitor probe should have disabled the irradiator. However, it was discovered that access could be gained to the radiation room by depressing the monitor test switch and repeatedly cycling the buttons on the panel of the radiation monitor. This method of gaining access became the 'usual' procedure. The access door had not been maintained and had become badly fitting, with the result that it could also be opened by force or by using the blade of a knife to slip the catch (see Photographs 5 and 6). Thus one major safety feature of the design was bypassed.*

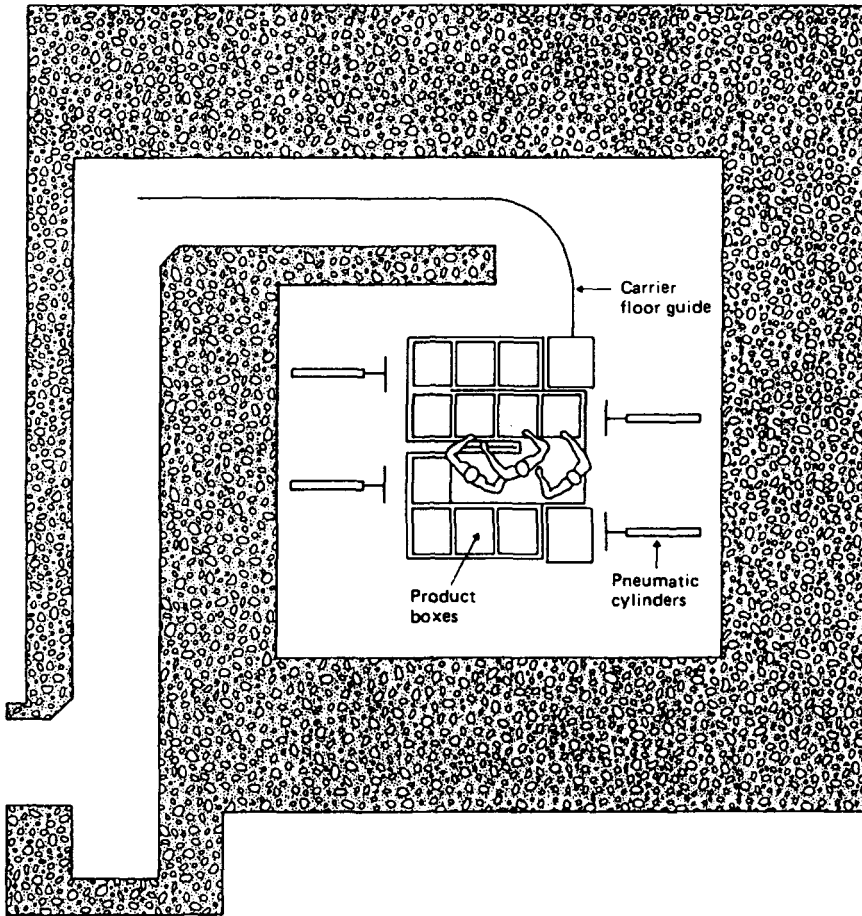
FIG. 12. Plan view of the positions of Workers A, B and C in the radiation room during the accident. (Source: REAC/TS.)

Shortly afterwards, at about 03:00, Worker A returned with Workers B and C, from another department, who had no experience of the irradiation facility. On being asked about any hazard, Worker A assured the others that there was no danger since the machine was switched off. The three men entered the radiation room and proceeded to remove product boxes from the third row on the upper level (adjacent to the source) so that the source rack could be freed from above (see Figs 12 and 13).

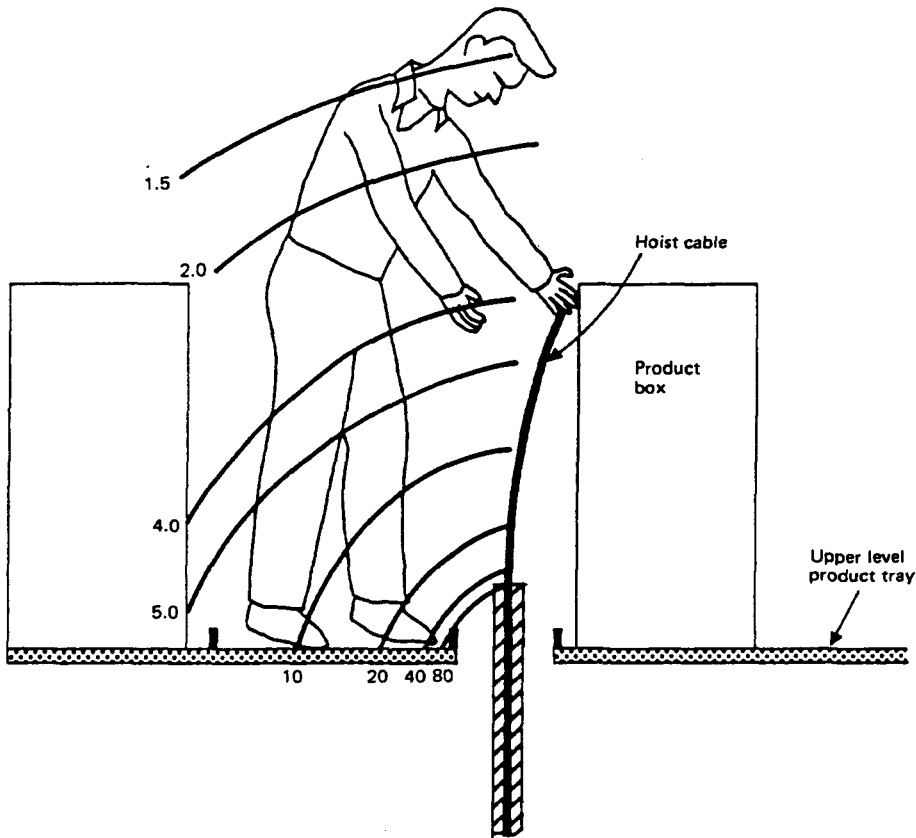
FIG. 14. Dose rate contours for a standing figure: rates in  $Gy \cdot min^{-1}$ . (Source: REAC/TS.)

The next phase of the accident was probably when the three workers sustained the largest share of their doses. They would have been moving, but the positions and dose rate contours shown in Figs 13–15 can be taken as indicative of the patterns of exposure. In order to free the source rack they first had to raise it (a mass of about 60 kg) by all three pulling on the hoist cable. Eventually the three men were standing broadly in line on the upper level (Fig. 16). Worker A was in a crouching position with his legs slightly apart and his right leg forward directly in front of the rack. To his right, Worker B had his left leg nearer the source. (The leading leg of each man

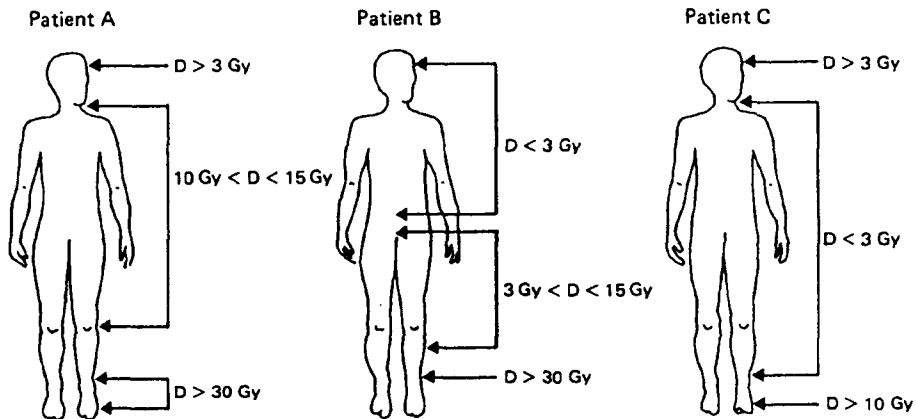
FIG. 17. Patients A, B and C: doses  $D$  incurred by different parts of the body. (Source: REAC/TS.)

From Day 32 to Day 36 (Wednesday 8 to Saturday 12 March) the medical team at the Angeles del Pedregal Hospital in Mexico City worked together with the IAEA expert team from REAC/TS to assist in both medical and dosimetric aspects. Assessments of the patients' dose distributions were made on the bases of the onset and extent of epilation and dry and wet desquamation and early signs of necrotic lesions. These assessments, which did not substantially change afterwards, are presented in Fig. 17.

Patient A: 8.1 Gy  
Patient B: 3.7 Gy  
Patient C: 2.9 Gy.

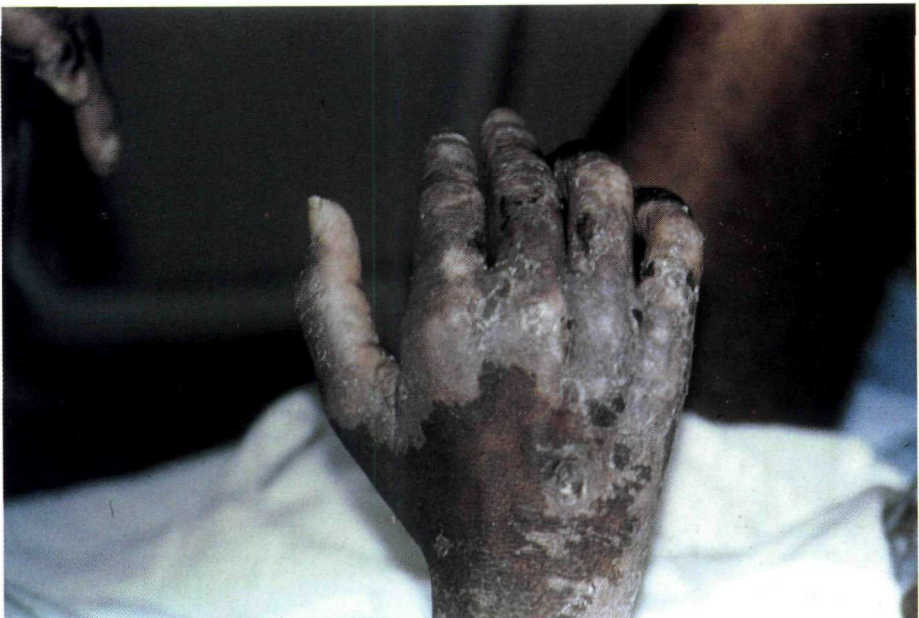
17. *Patient A (Day 26): burns to the hand.*

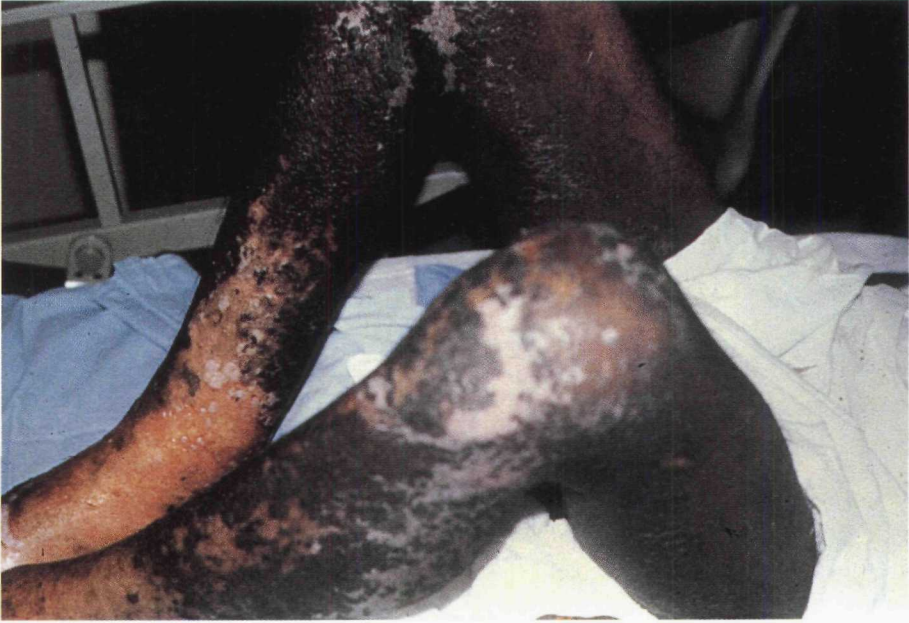
18. *Patient A (Day 26): burns to the legs and feet.*

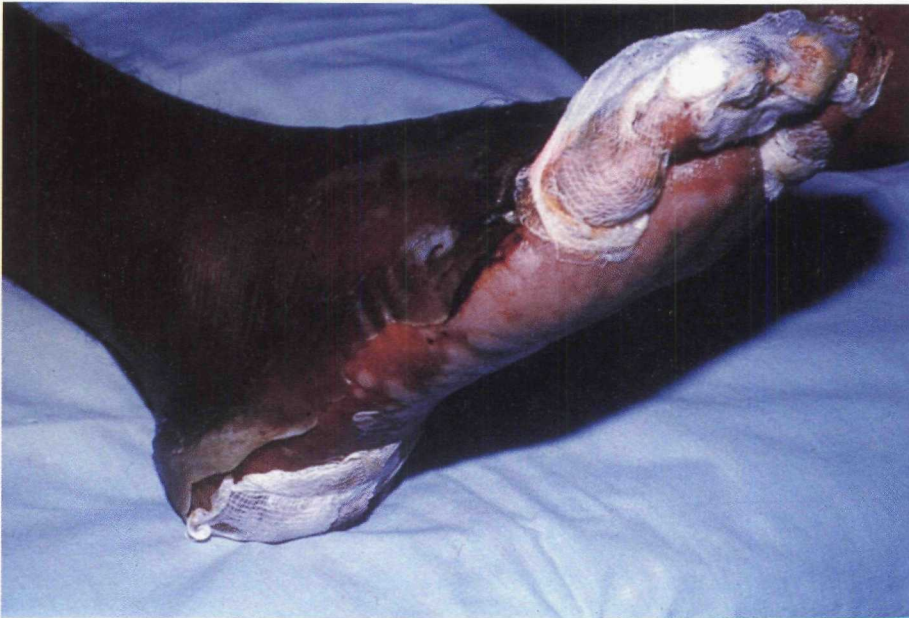
19. *Patient A (Day 26): the more exposed foot.*

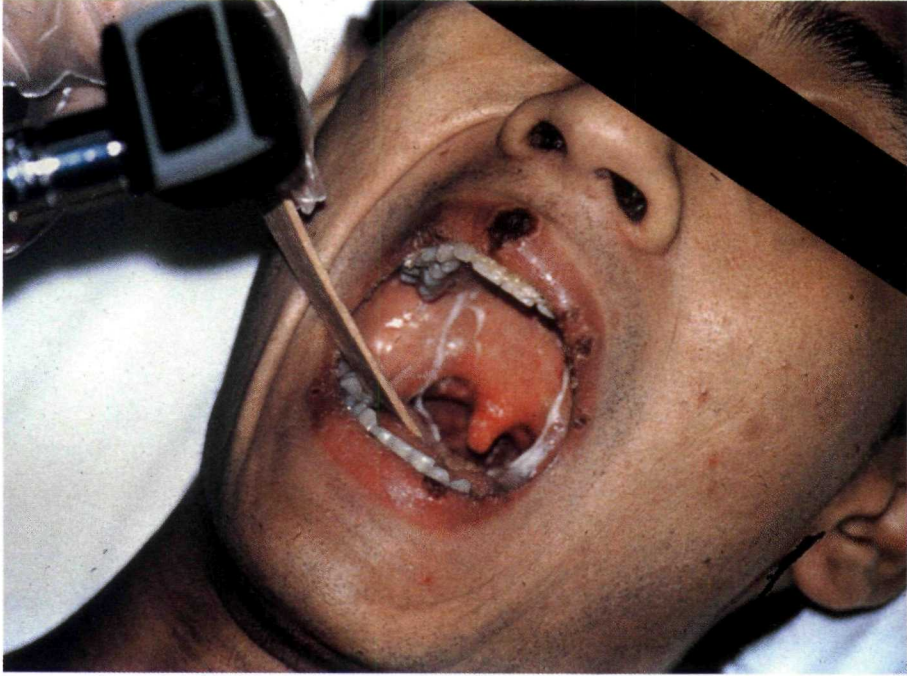
20. *Patient B (Day 26): mouth sores; Patient A had similar sores.*

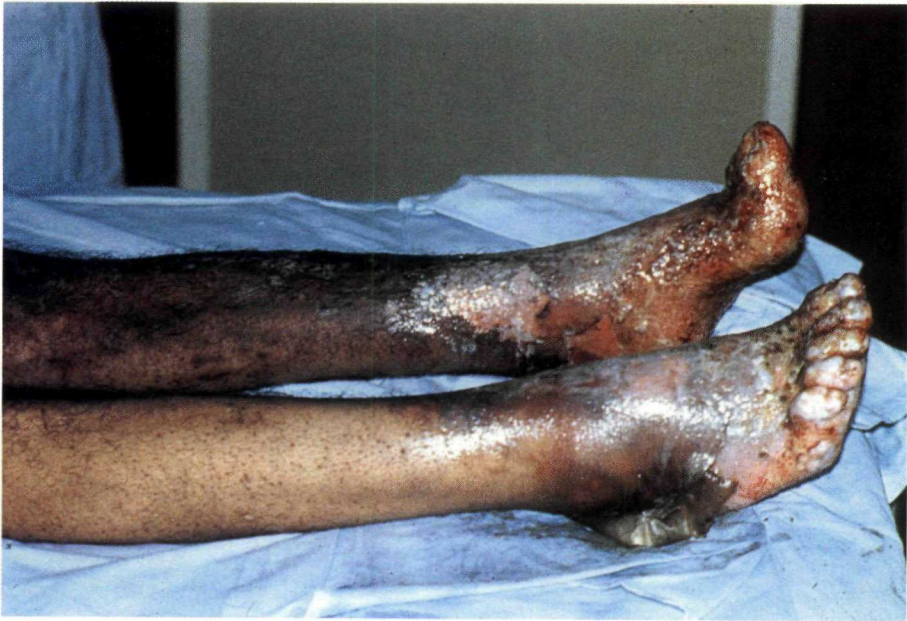
21. *Patient B (Day 26): burns to the legs and feet.*

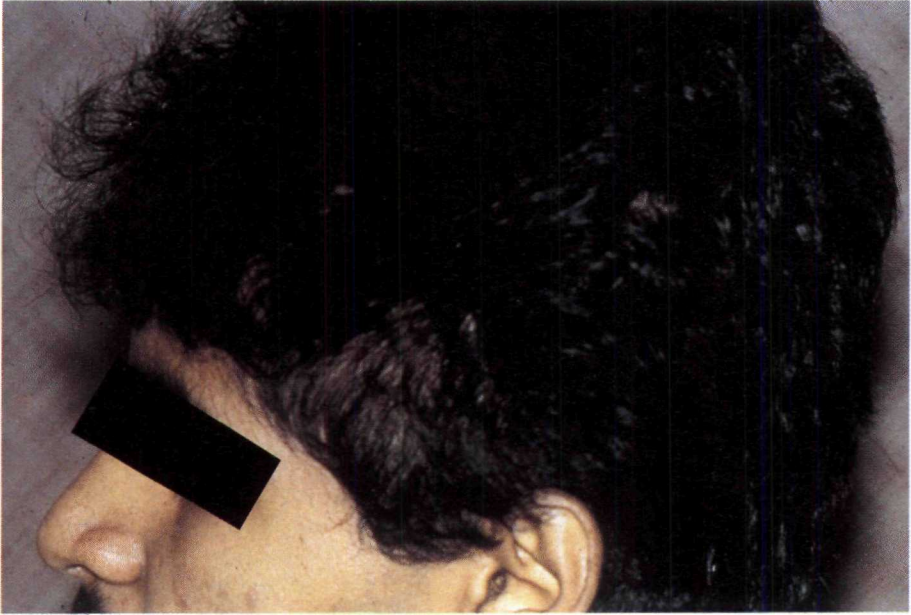
22. *Patient C (Day 33): radiation induced temporary hair loss.*

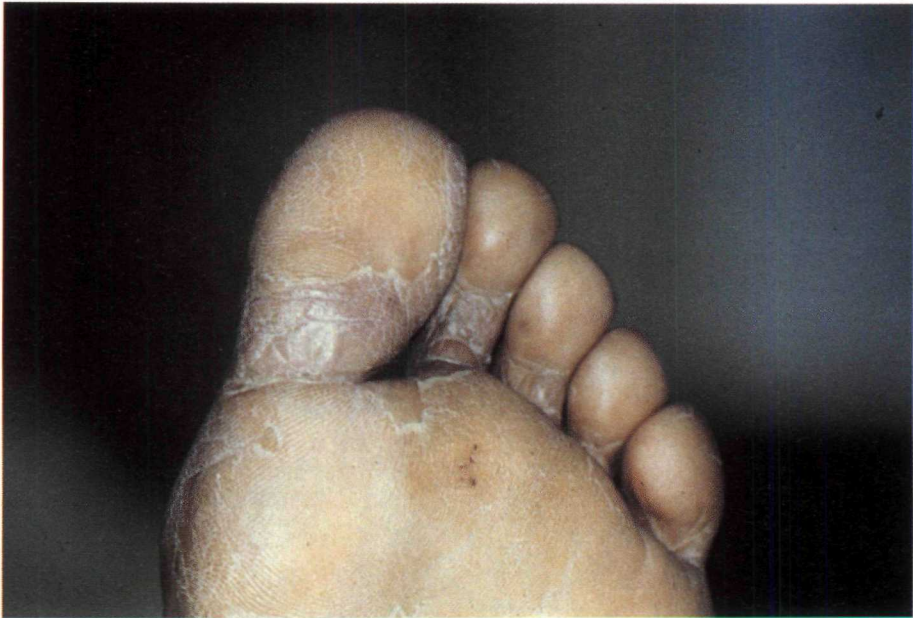
23. *Patient C (Day 33): healing of burns to toes.*

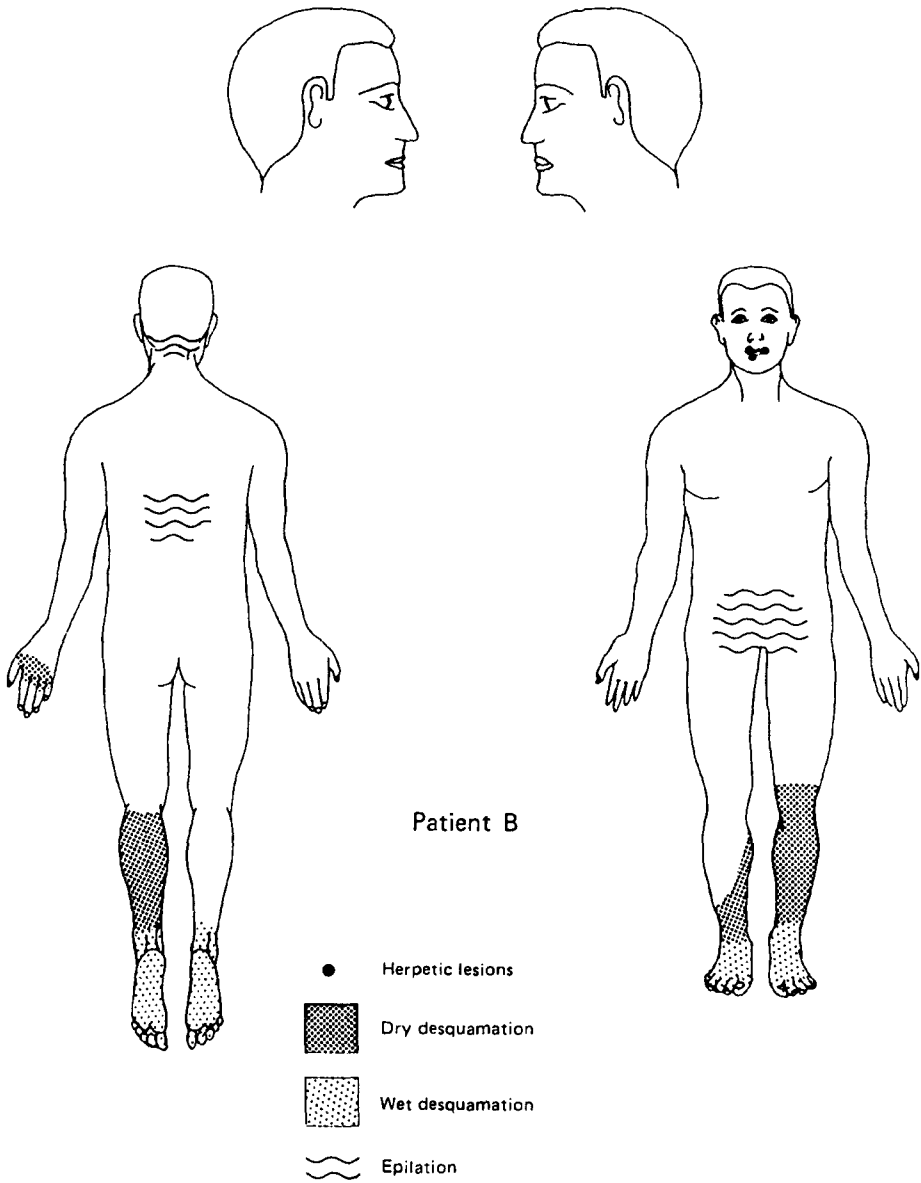
FIG. 19. Patient B: corporal distribution of effects of exposure. (Source: REAC/TS.)

Severe radiation injuries to the skin and underlying tissues of the lower extremities of Patients A and B were manifested by swelling, erythema, hyperpigmentation, epilation, and dry and wet desquamation. Radiodermatitis was observed in the anterior abdominal wall and chest in Patient A, and swelling of the lower legs after three days. Significant oedema and erythema were seen after a week in Patient A. Epilation with dry and wet desquamation was evident by a week after the accident (see Figs 18–20). The patterns of epilation and desquamation as well as the degree and extent of local skin injury reflect each person's position in relation to the source at the time of the exposure.
