# A 'Smart' Approach to Building Back Better After Hurricane Irma

## Adina Donovan Home

Road Town, Tortola, British Virgin Islands

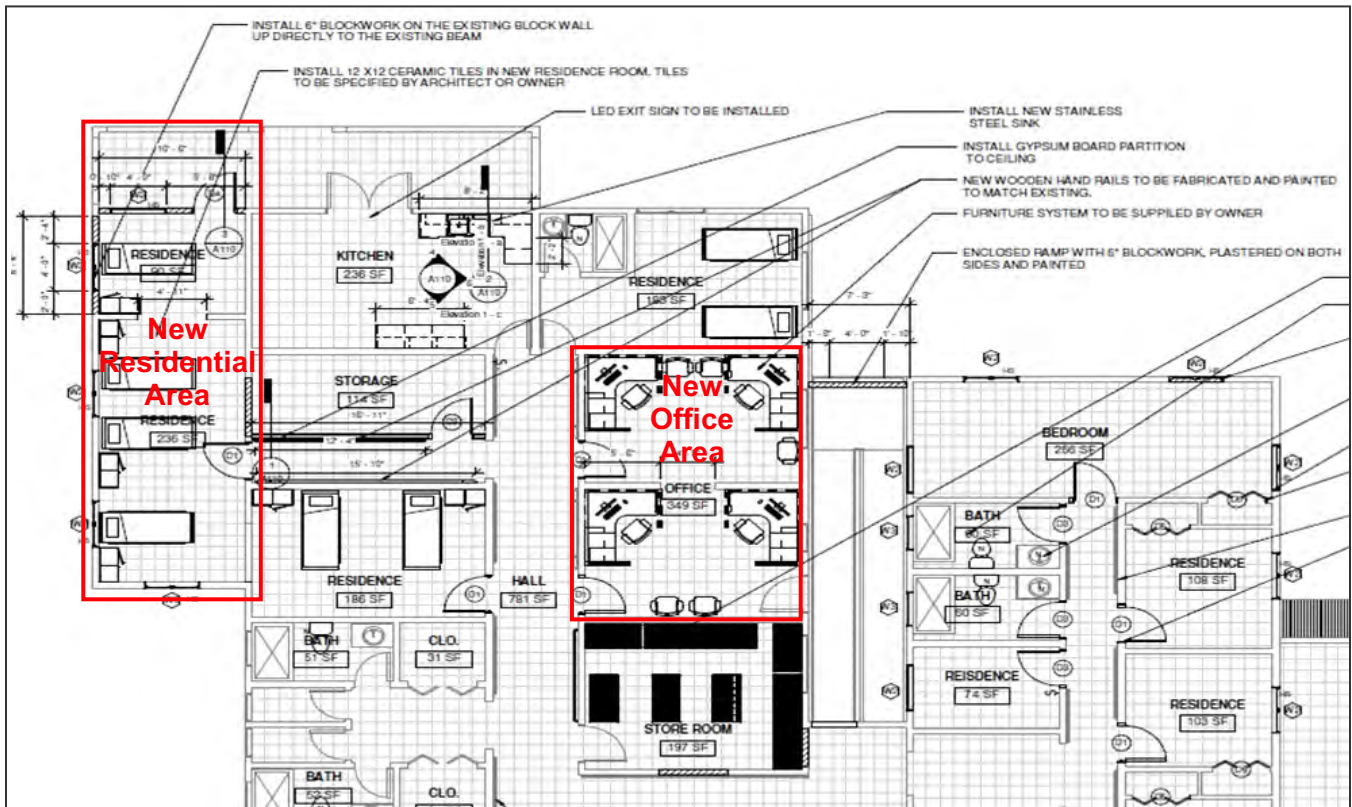
Figure 1 New Areas

overall space utilization. Former storage spaces were converted into residential areas that accommodate 4 additional beds which increased the capacity of the facility to 28 residents. A new layout to the office area was provided which added for more working space for staff. Additional aims of the renovations included improved hygiene in the kitchen areas and additional counter space. The kitchen area on the ground floor was renovated to include a new stainless-steel sink, new cupboards and a relocated exhaust fan. The cupboards in the kitchen on the upper floor were also replaced. Improvements to indoor environmental quality were made with the addition of inverter-type split air conditioning units and LED light fixtures, efficient toilets and faucets, new furnishing, new appliances, and medical equipment and beds.
